Eversource – New Hampshire Asset Condition Wood Structure Replacements

Planning Advisory Committee Meeting

June 15, 2022

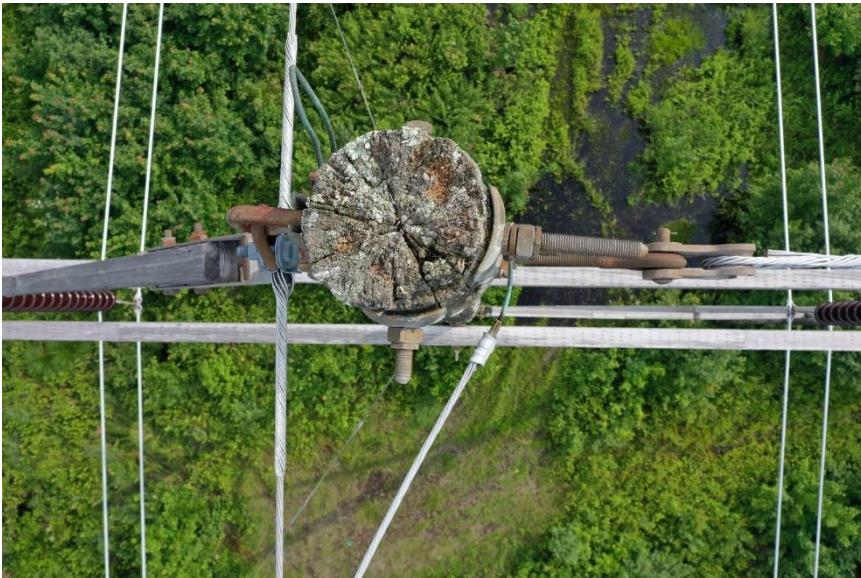
385 Line – Top Rot and Splitting

- Inspections have indicated significant degradation of several round and laminated wood structures along the identified lines in this presentation
 - Existing structures will be replaced with light duty steel equivalents
- All replacements will be designed to meet current design criteria
- Resolves multiple structural issues
- Supports long-term integrity and reliability of the Eversource transmission system

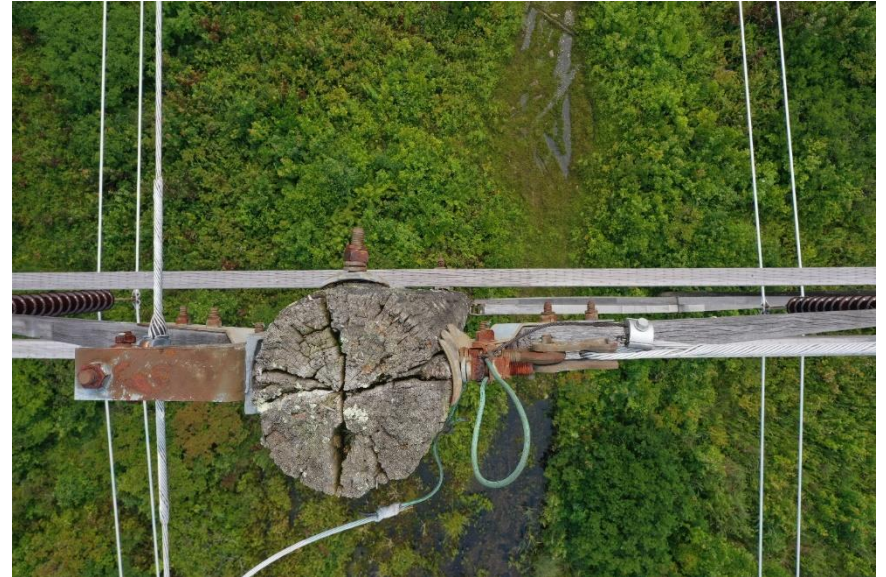
391 Line – Top Splitting and Cracking

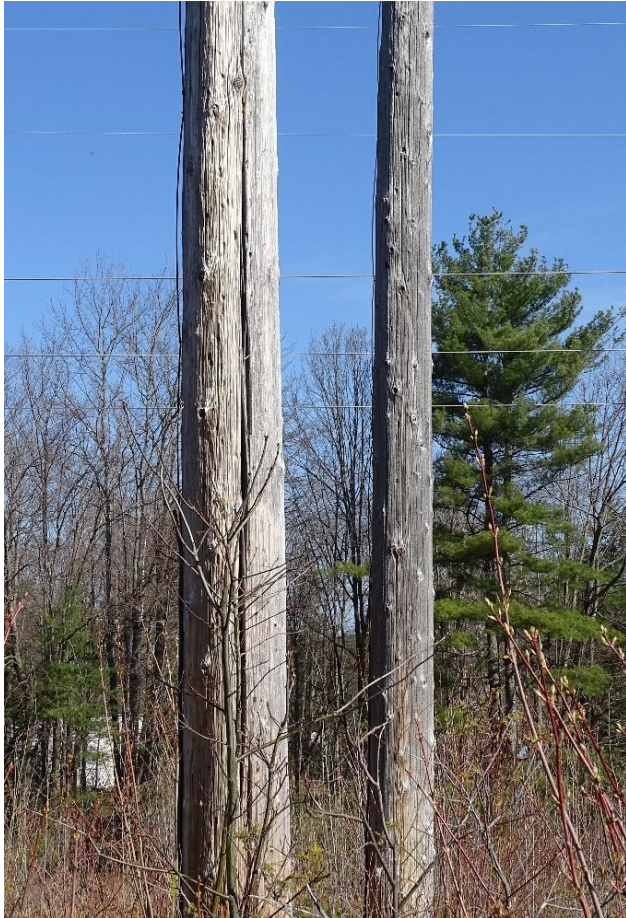
C196 Line – Pole Splitting

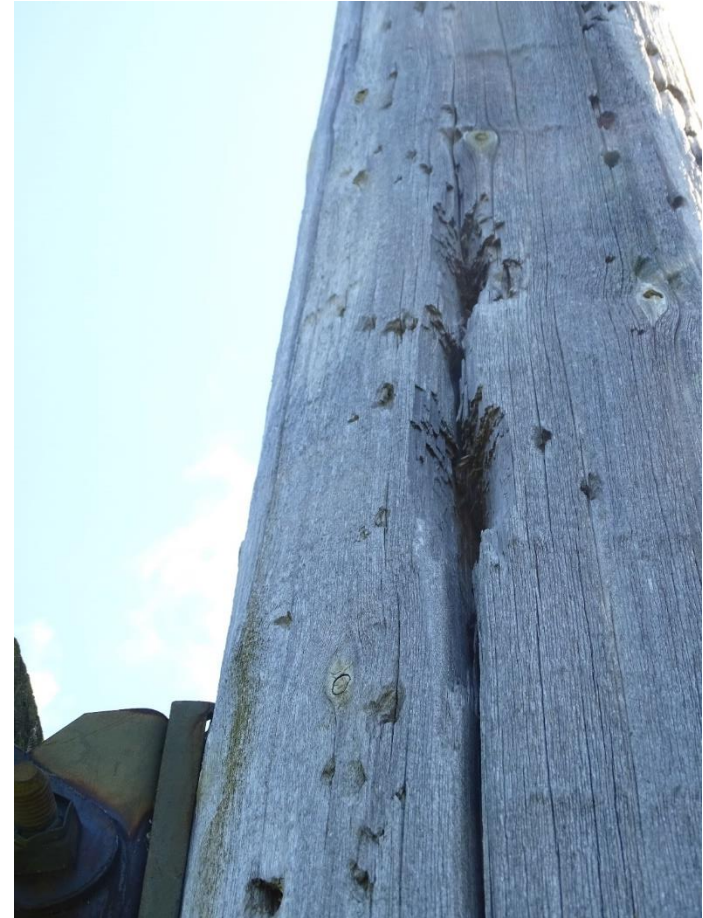
379 Line – Pole Splitting and
Woodpecker Damage

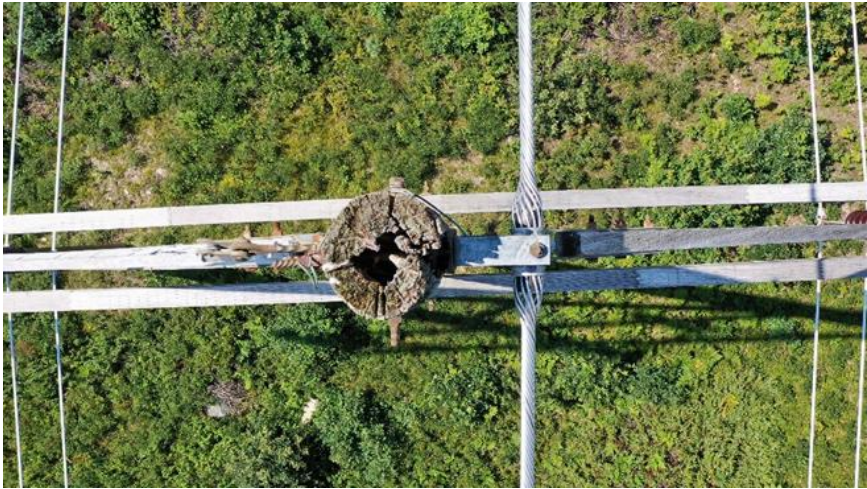
373 Line – Top Rot and Splitting

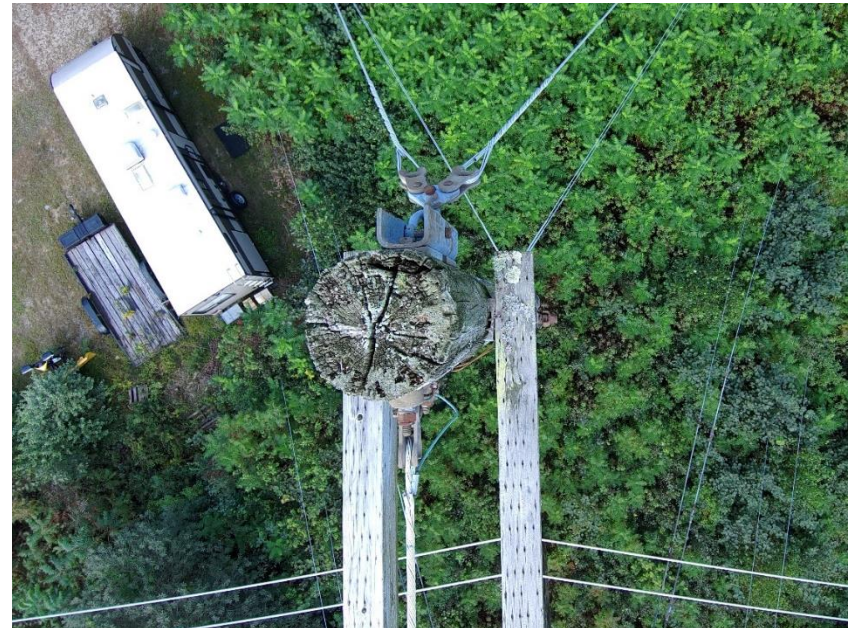
326 Line – Top Splitting and Cracking
