Eversource 115-kV and 345-kV Structure Replacements

Planning Advisory Committee Meeting

December 15, 2021

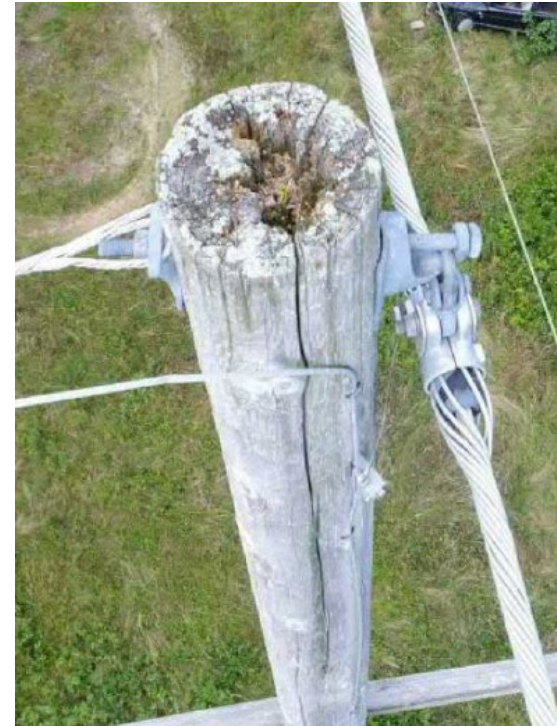
Line 191 Structure 27 –
Age, Decay, Rotted Pole Tops
