Eversource Copper Conductor and Shield Wire Replacement Projects

Planning Advisory Committee Meeting

January 21st, 2021

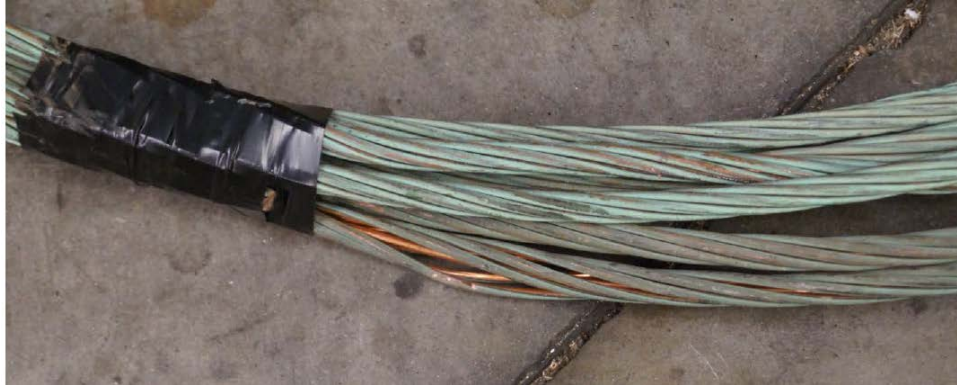
Damaged Strand of Existing 2/0 Copper Conductor Sample

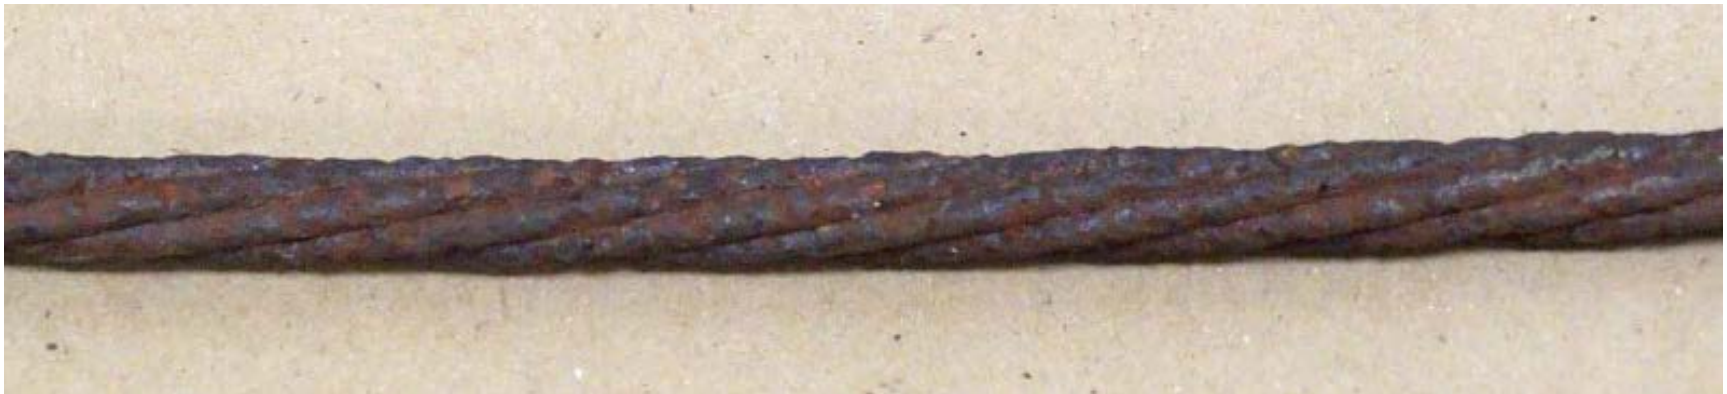
Severe Corrosion of 3/8 Shield Wire Sample

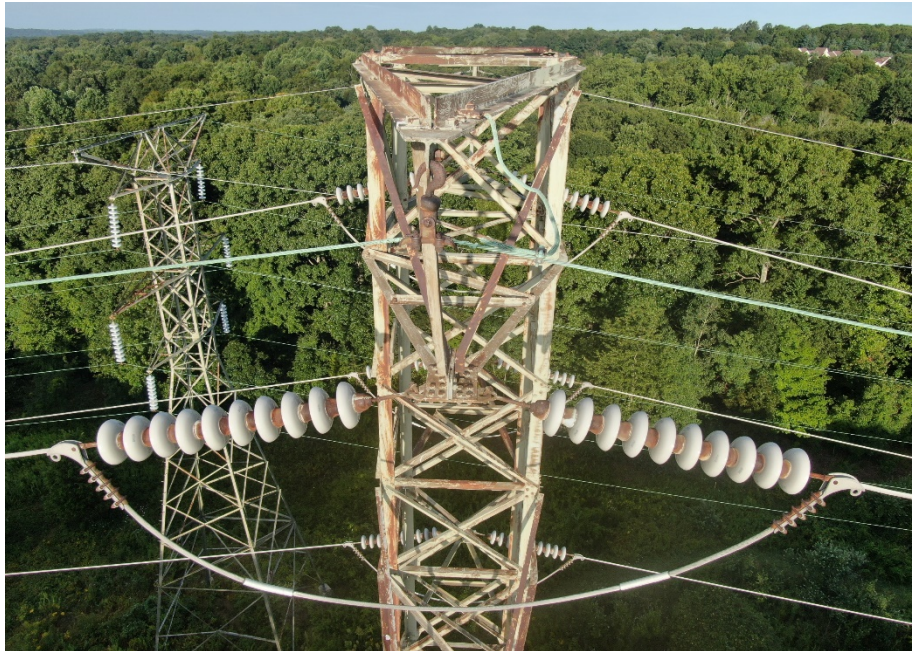
Lattice Tower Degradation –
Structure #1362

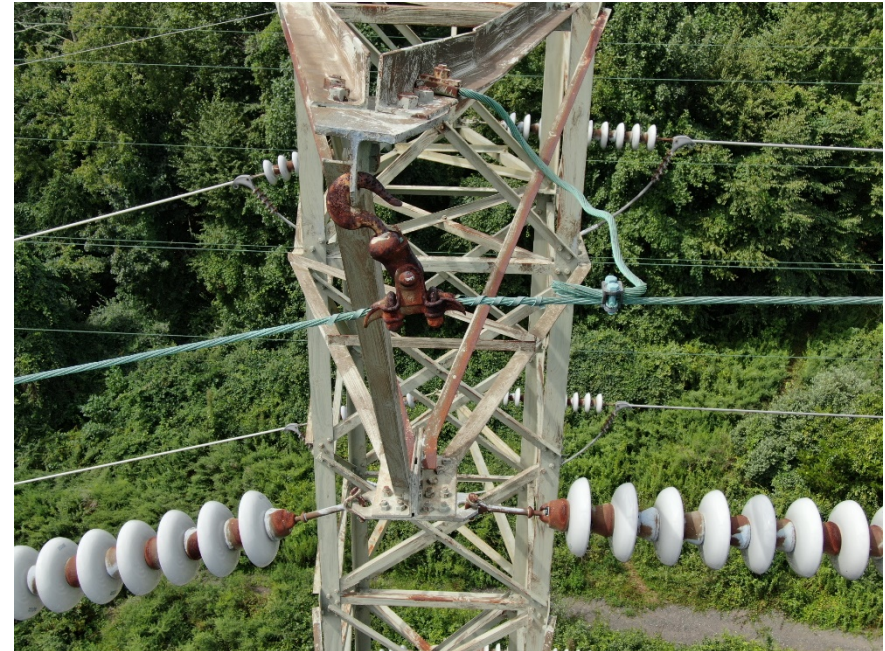
Lattice Tower Degradation –
Structure #1348

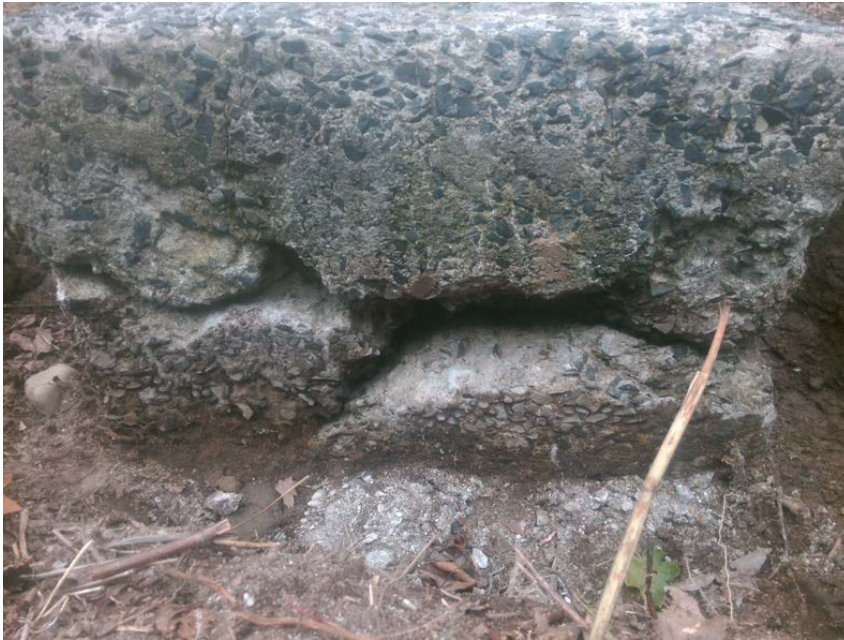
Damaged, Cracking, Crumbling Lattice Tower Leg
Foundation – Structure #233

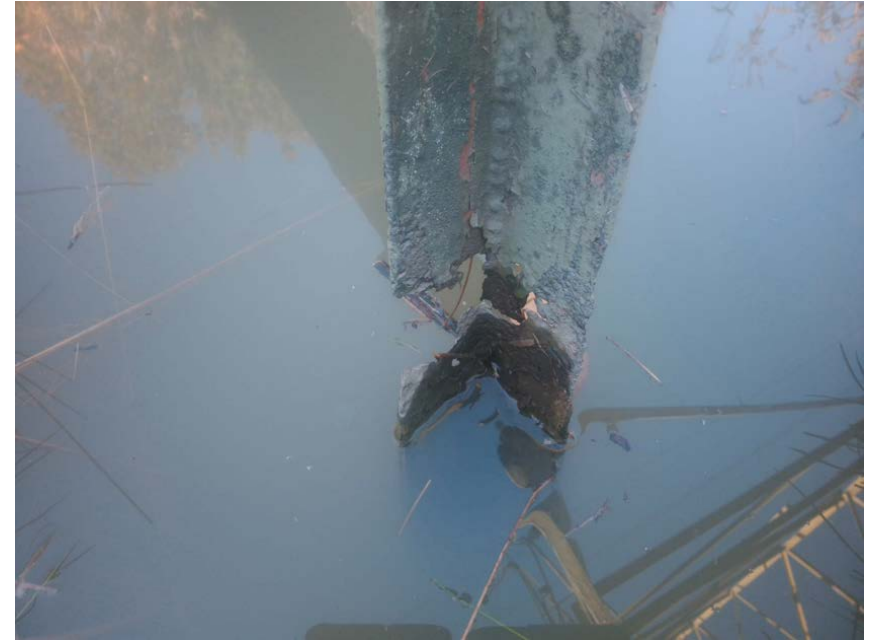
Lattice Tower Leg in Standing Water, Rusty and Eroding
– Structure #248

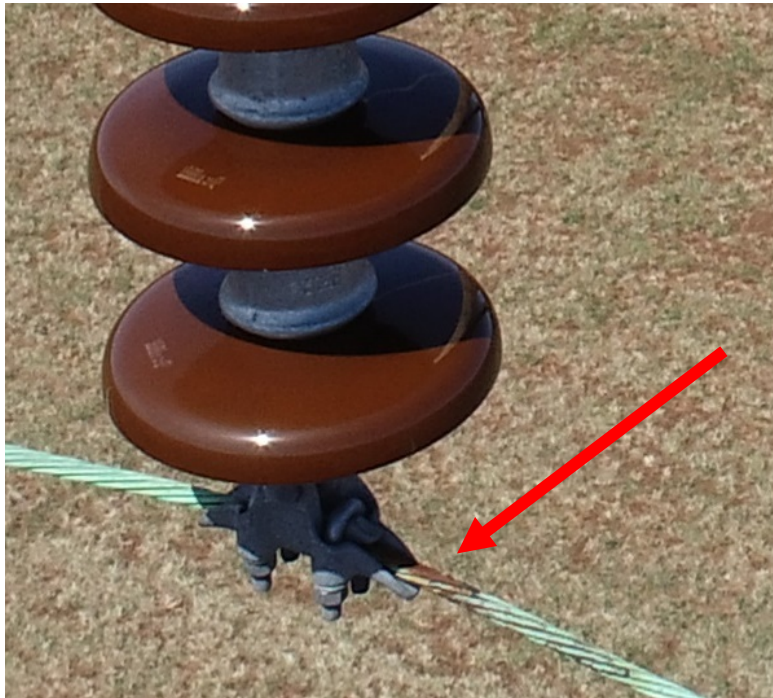
Corrosion of Copper Conductor –
Line 1588

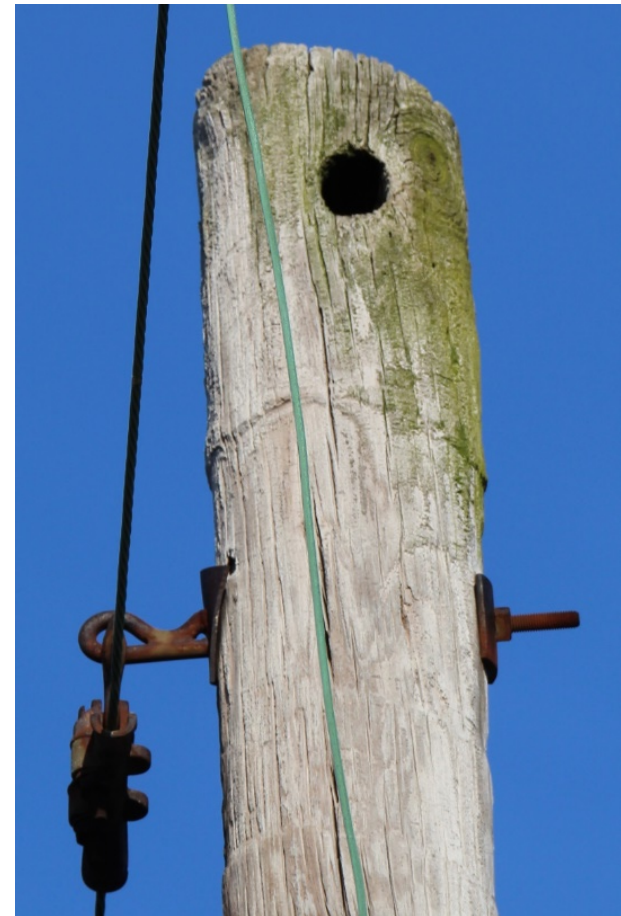
Split Pole Tops, Cracks and
Woodpecker Damage –
Structure #3624

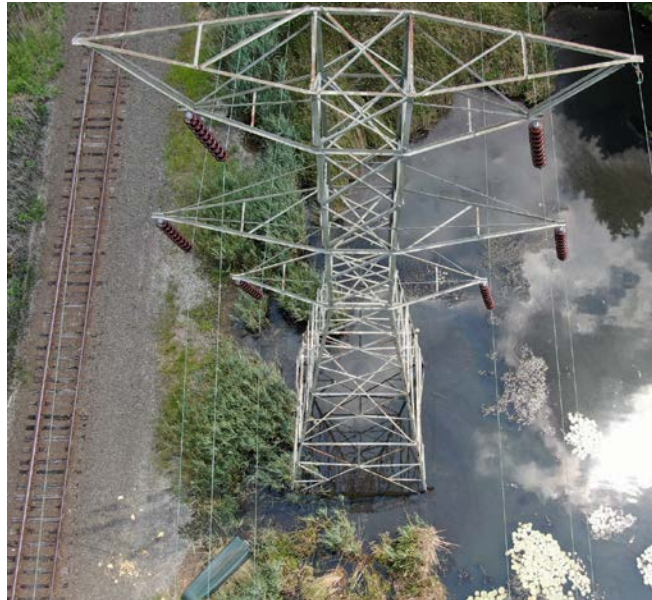
Lattice Structures in Standing Water and Wetlands Along Train Tracks Between Brookfield Jct and Structure #4620

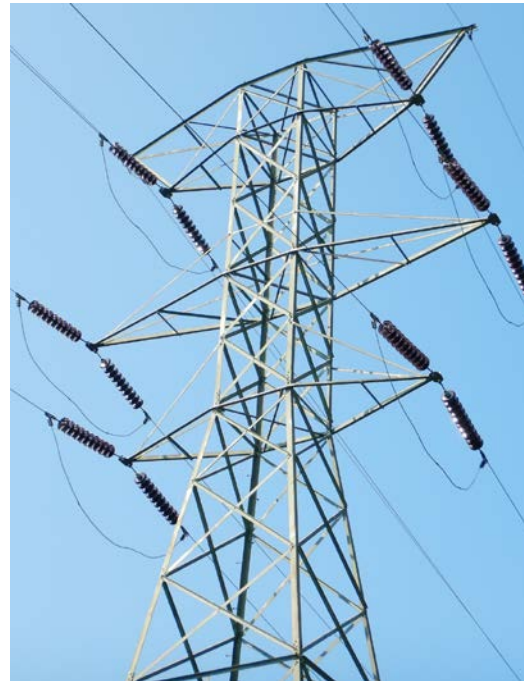
Typical Lattice Structure on Lines 1485 and 1887 with 4/0 Copper – New Conductor and Shield Wire Would Overstress the Structures

- Replacement of 36 lattice towers with direct-embed monopoles
- 89 structures to remain
- Potential replacement of additional structures based on structure analysis
- Installation of counterpoise

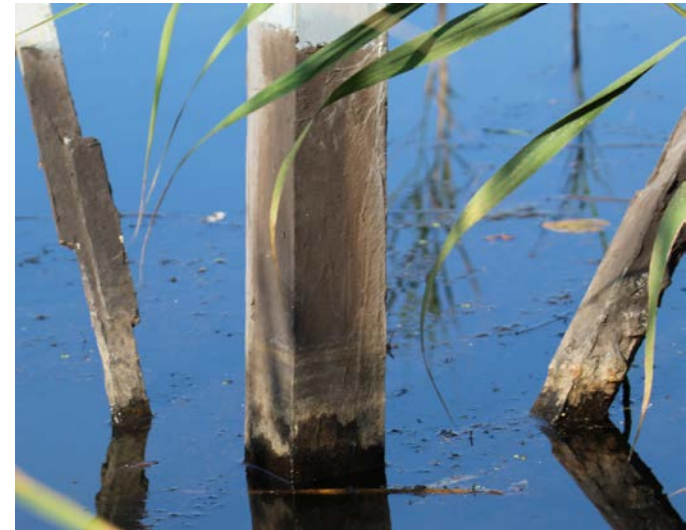
Lattice Structure in Standing Water and Wetlands Along Train Tracks

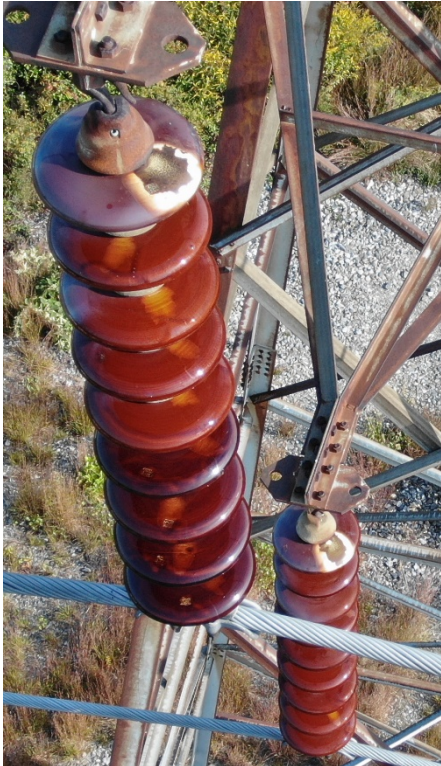
Damaged Flashed Insulators –
Lattice Structure #25

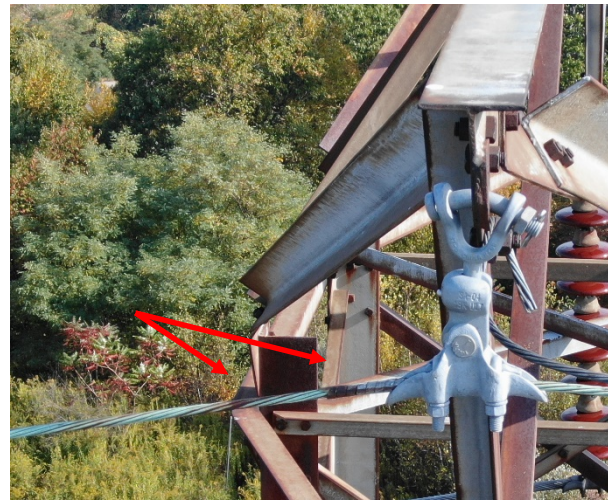
Corrosion of Copper Shield Wire

- 1550: Replacement of 3.5 miles of copperweld shield wire with OPGW between Frost Bridge substation and Noera Junction

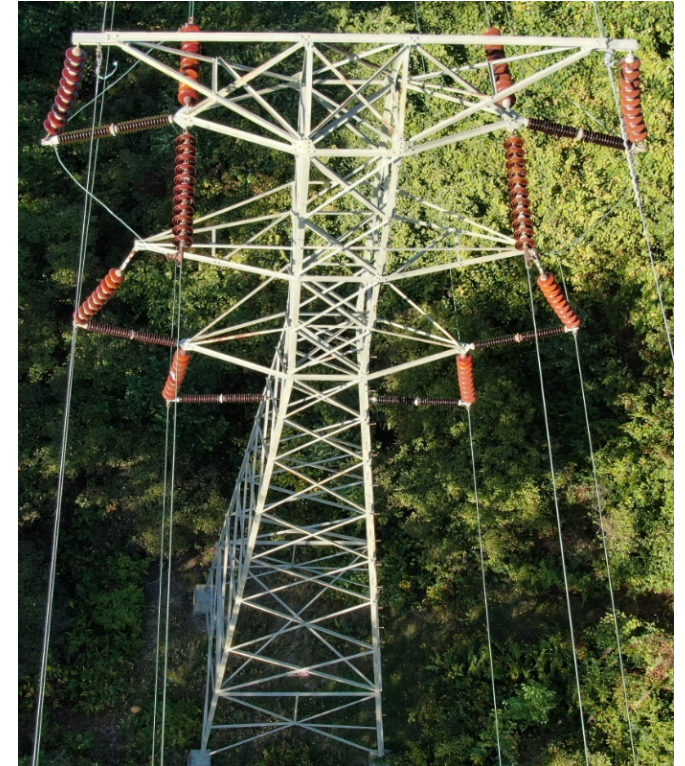
Existing Lattice Towers Built to
69-kV Spec

- Replacement of 26 lattice towers with direct-embed, steel monopoles or engineered steel monopoles on concrete foundations
- 24 structures to remain

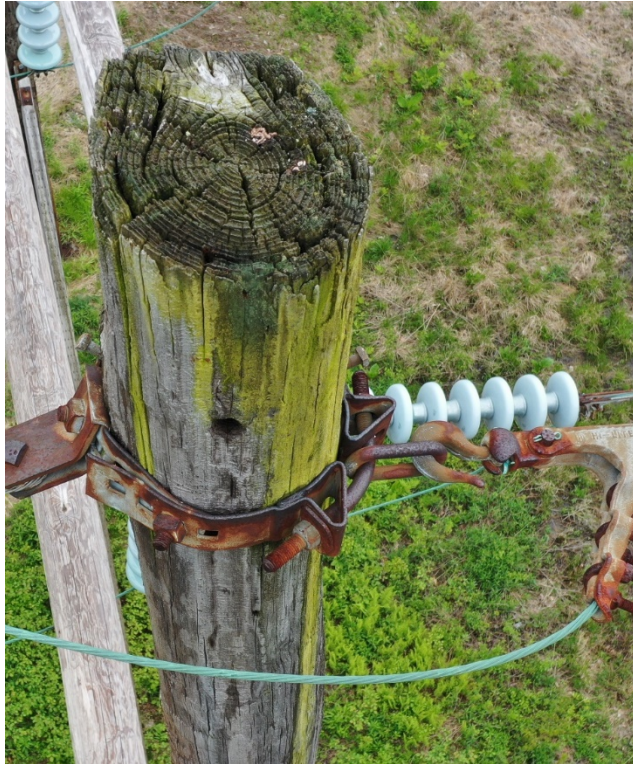
Rotten and Split Pole Top,
Woodpecker Damage –
Structure #1845

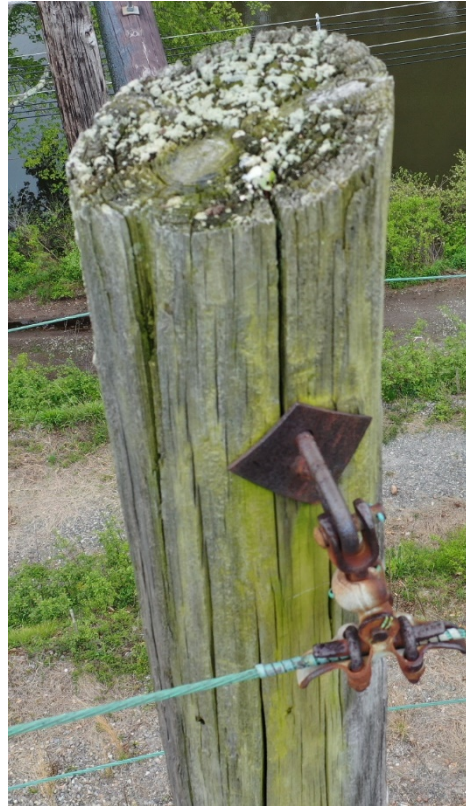
Split Pole Top, Woodpecker
Damage –
Structure #1847

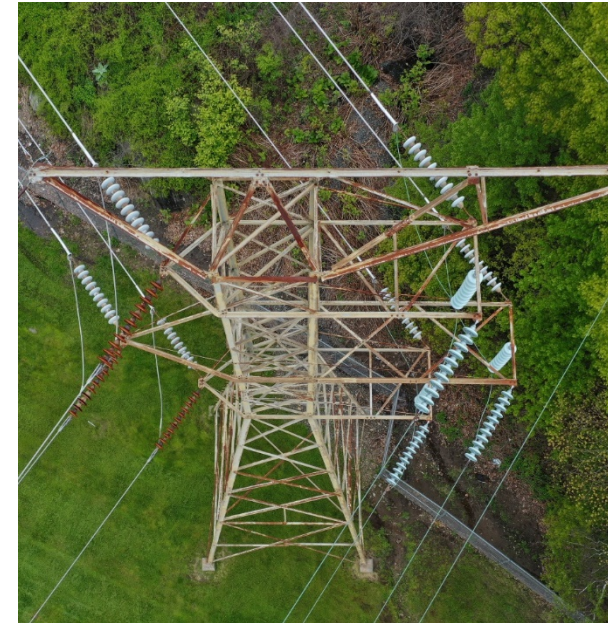
Rust on Steel, De-Galvanizing –
Structure #8169

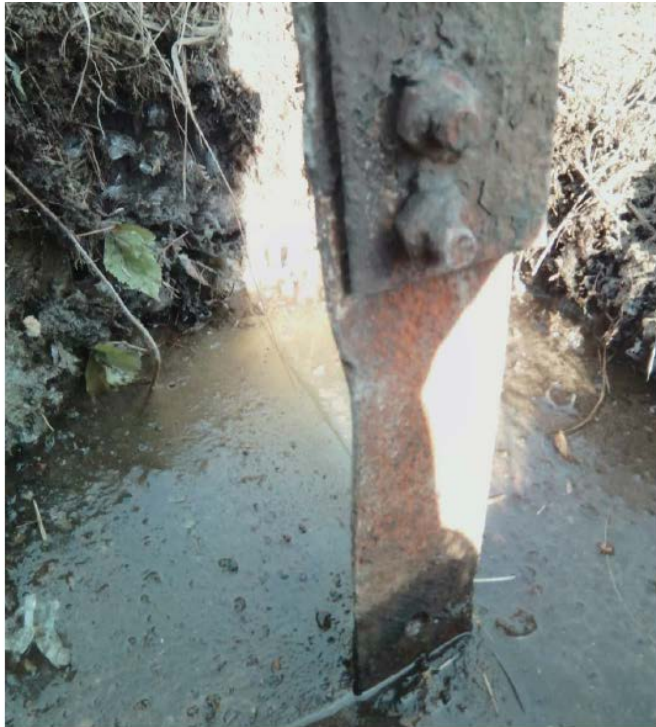
52.9% Section Loss of Leg Below Grade
– Structure 31223

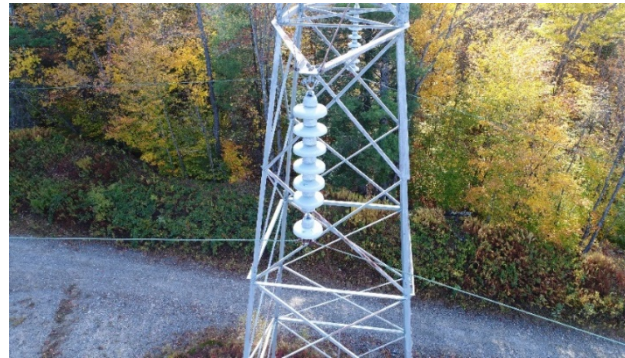
Structure 31231 – Missing Insulator Bell

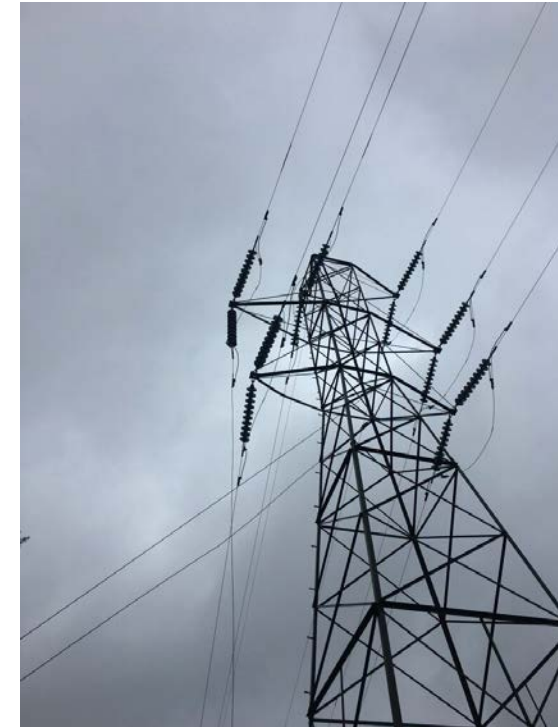
Broken Arm – Structure 31052

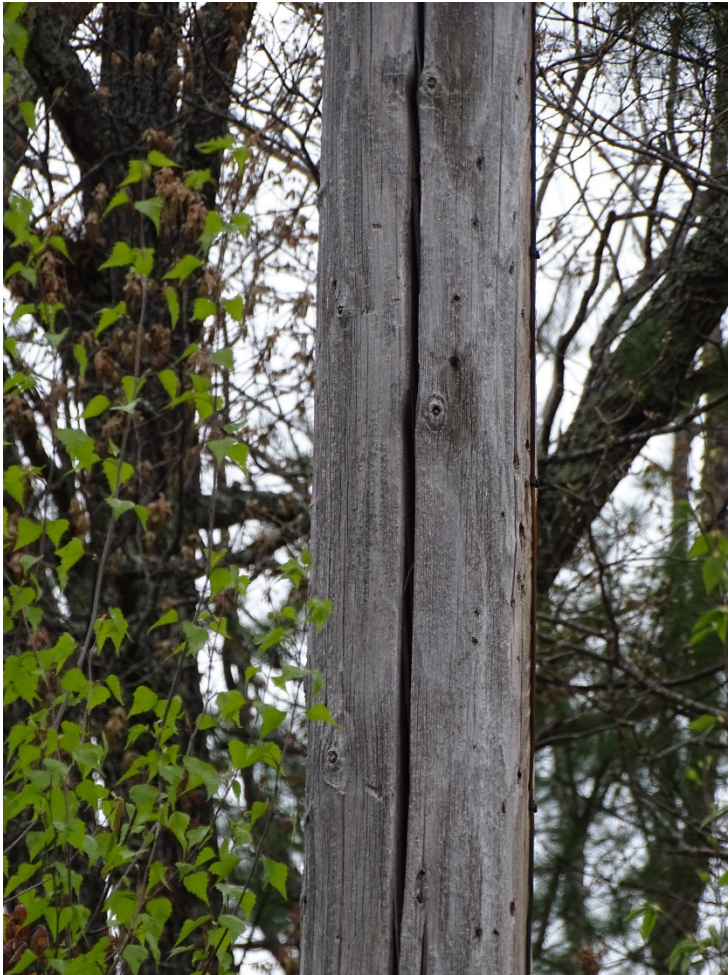
Typical Pole Split/Woodpecker Damage –
Line C129

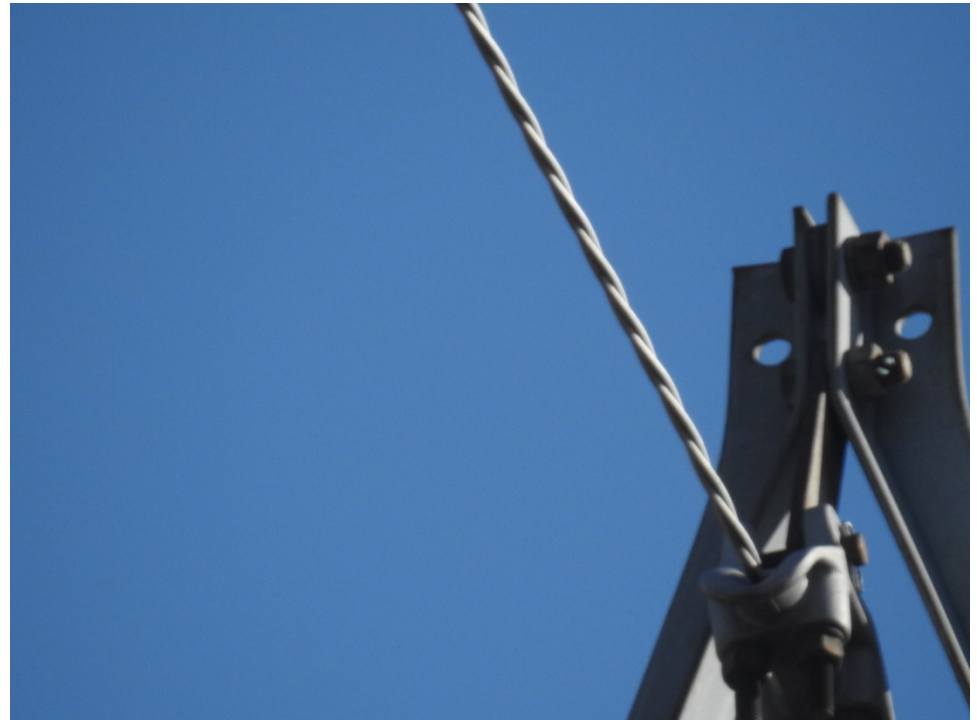
EHS Steel Shield Wire –
Line C129

- **Shield Wire Scope:**
 - Replacement of 7.1 miles of Extra High Strength (EHS) Steel shield wire with OPGW between Eastport substation and intersection with L175 Line
 - EHS steel shield wire is an obsolete material that is no longer in use on the Eversource system and connectors are no longer available
- **Structure Replacement Scope:**
 - Replacement of 61 wood H-Frame structures with light duty direct-embed steel structures
 - 225 structures to remain
 - Installation of lightning arrestors

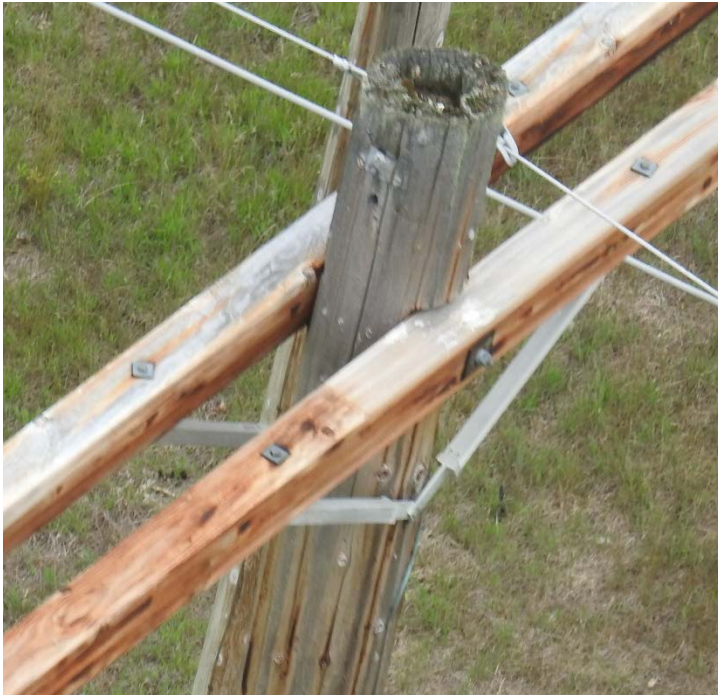
Pole Top Rot –
Structure #284

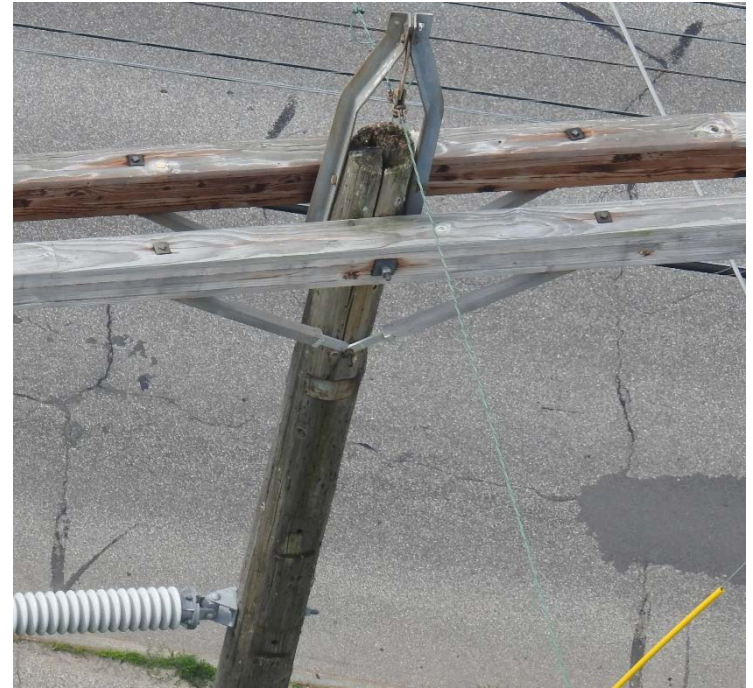
Pole Top Rot, Split Pole at
Crossarm – Structure #291

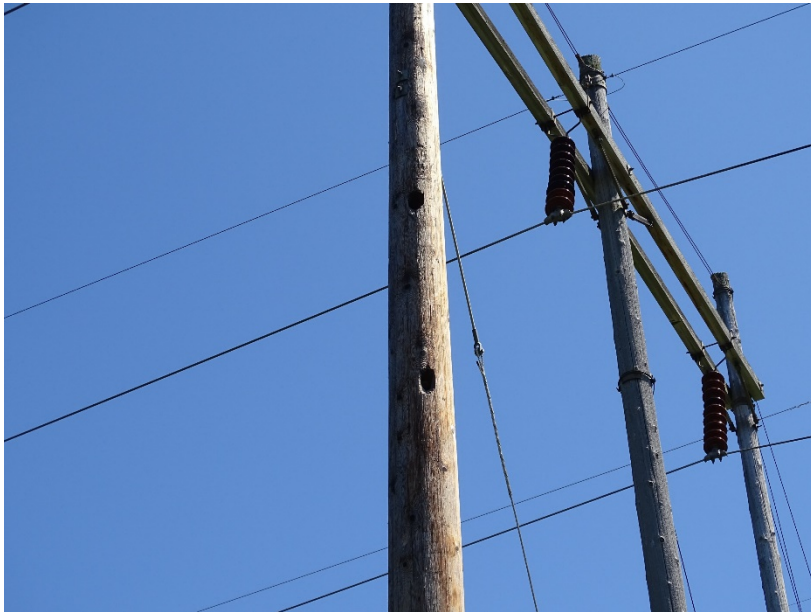
Typical Woodpecker Damage –
G128 Line

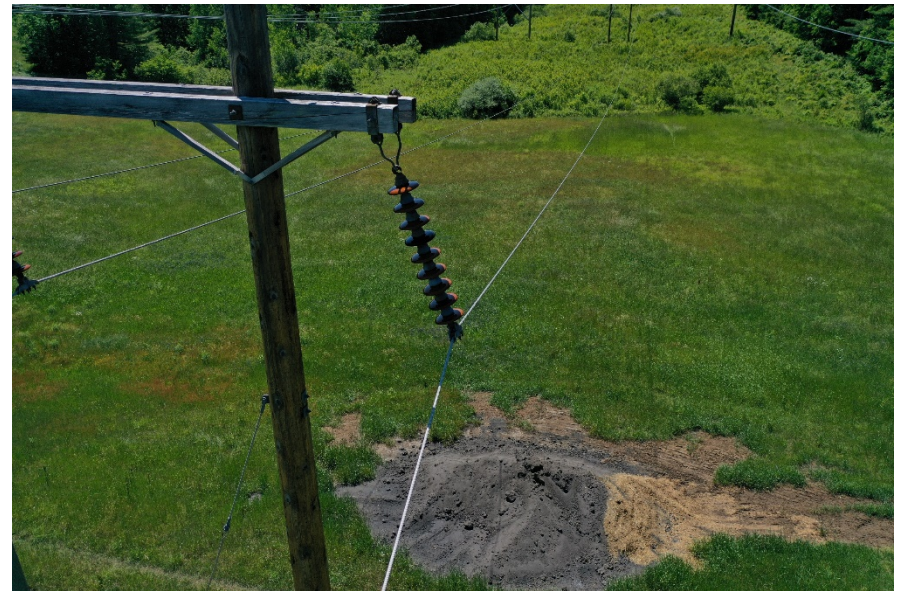
Typical Crossarm Damage –
G128 Line

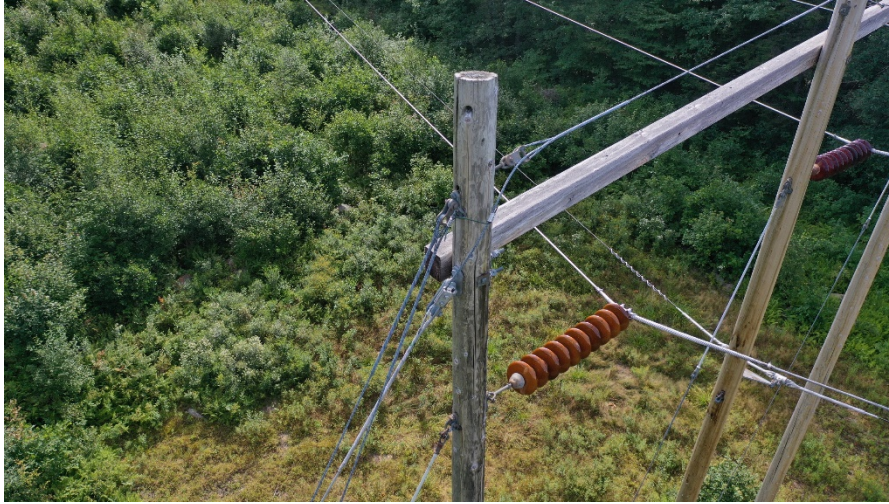
Pole Split and Woodpecker Damage –
Structure #205

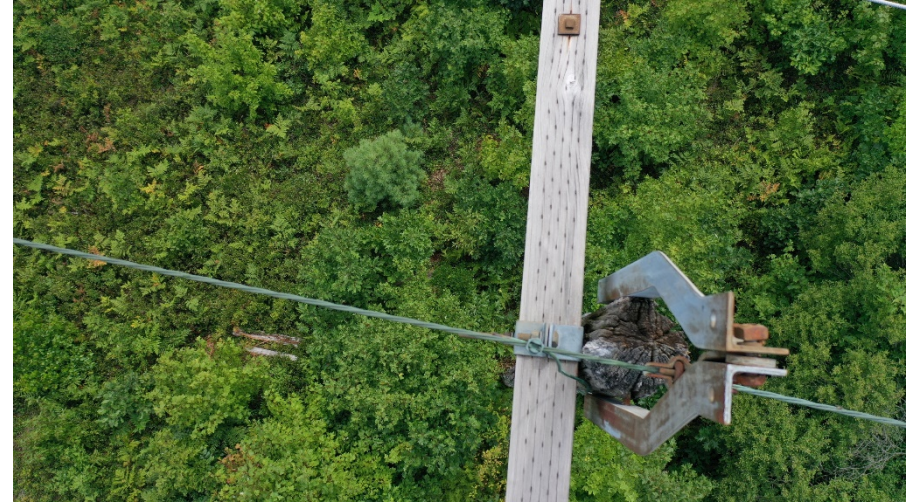
Pole Top Rot –
Structure #65

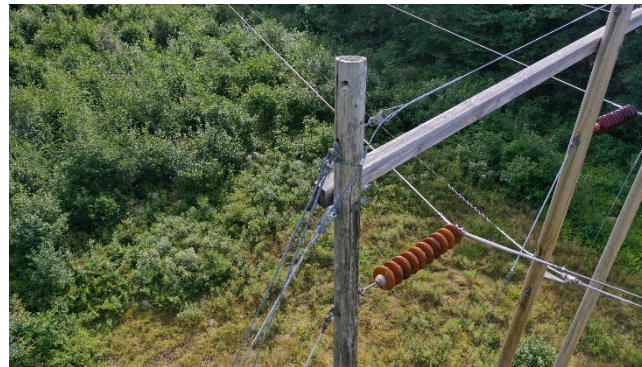
Pole Split –
Structure #95

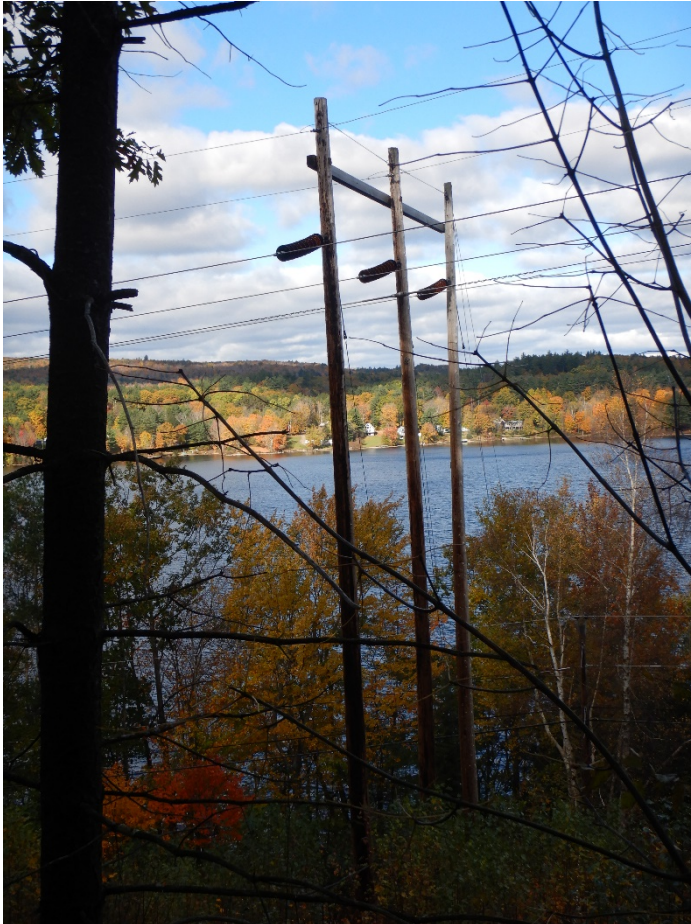
Typical Pole Splits/Woodpecker
Damage – X104 Line

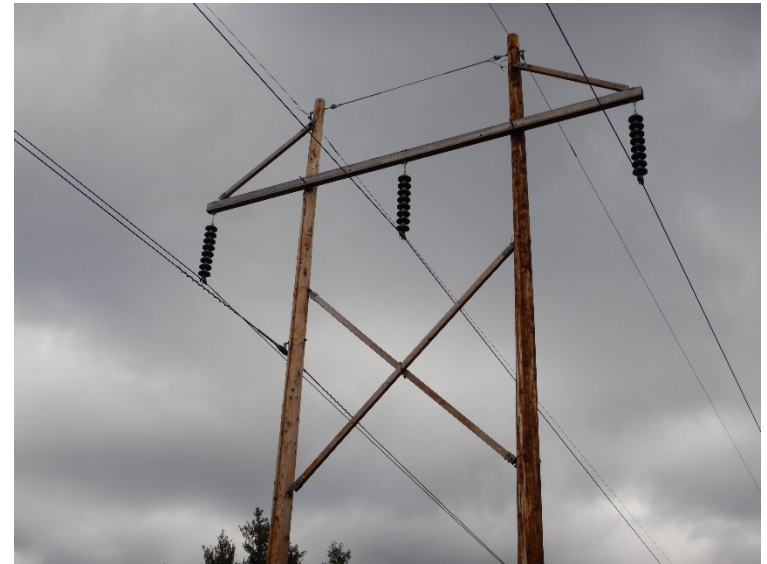
Typical Woodpecker Damage –
X104 Line
