Eversource X178 Decommissioned Pole Removal Phase II Report

Easton, Lincoln, & Woodstock, NH

January 2016

Prepared By:
Normandeau Associates, Inc.
25 Nashua Road
Bedford, NH 03110
www.normandeau.com

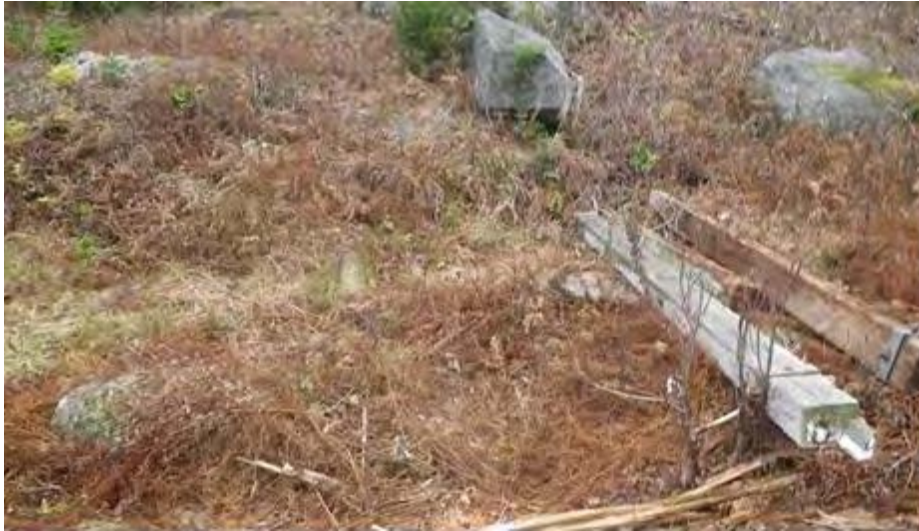
STR 243 cross arms awaiting removal – 11/2/15

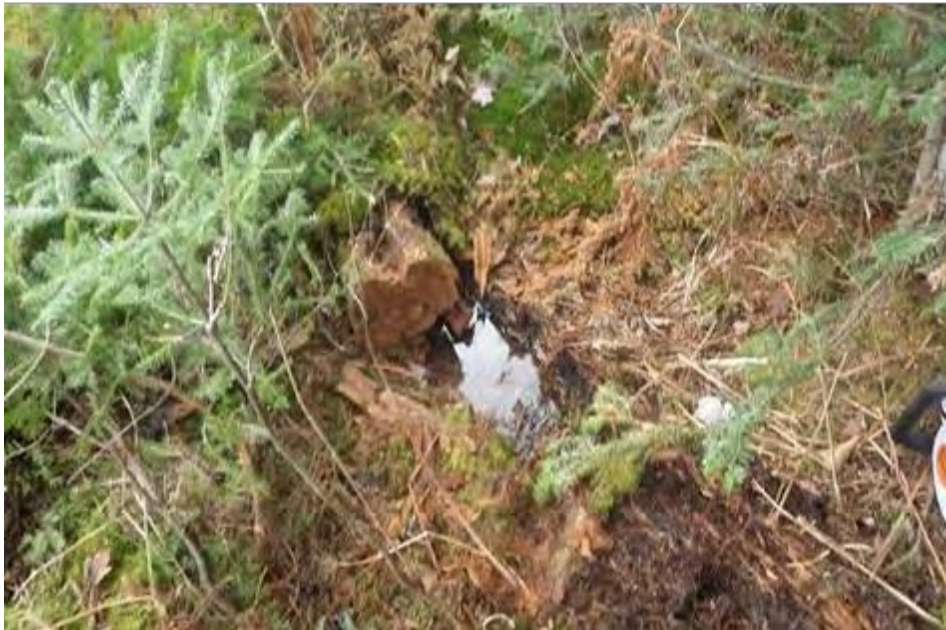
Pole piece not removed – 11/2

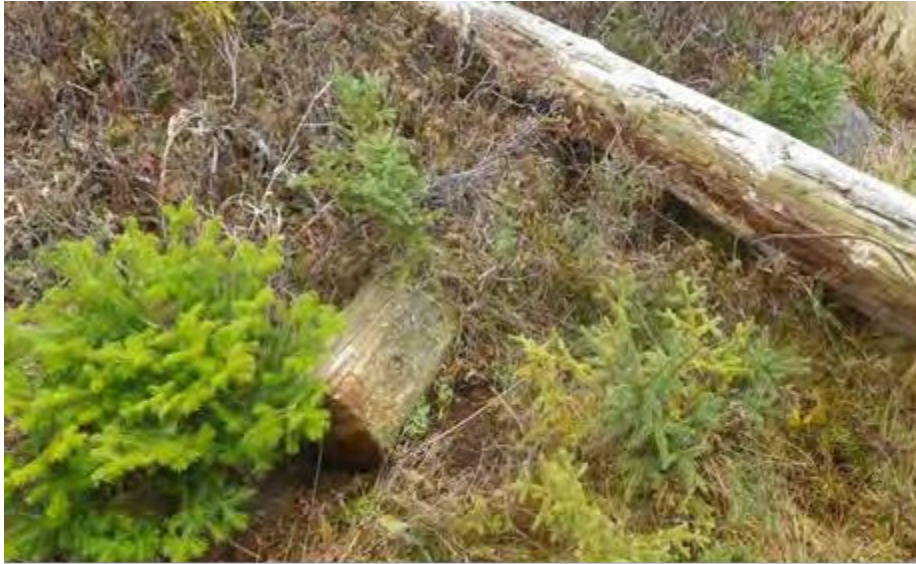
We counted approximately 20 poles removed along with 4 cross arms and various pieces of hardware. One half pole was left in the wetland near structure 246, one pole left in the wetland at #247

#246 pole not removed from wetland – 11/3

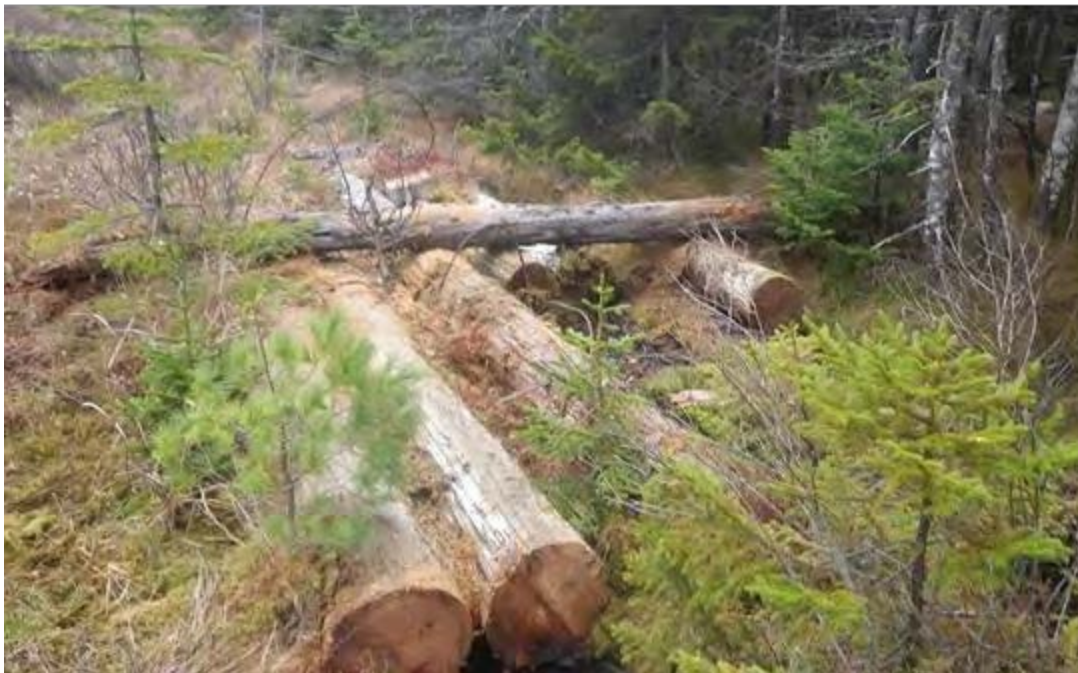
#264 pre removal – 11/3

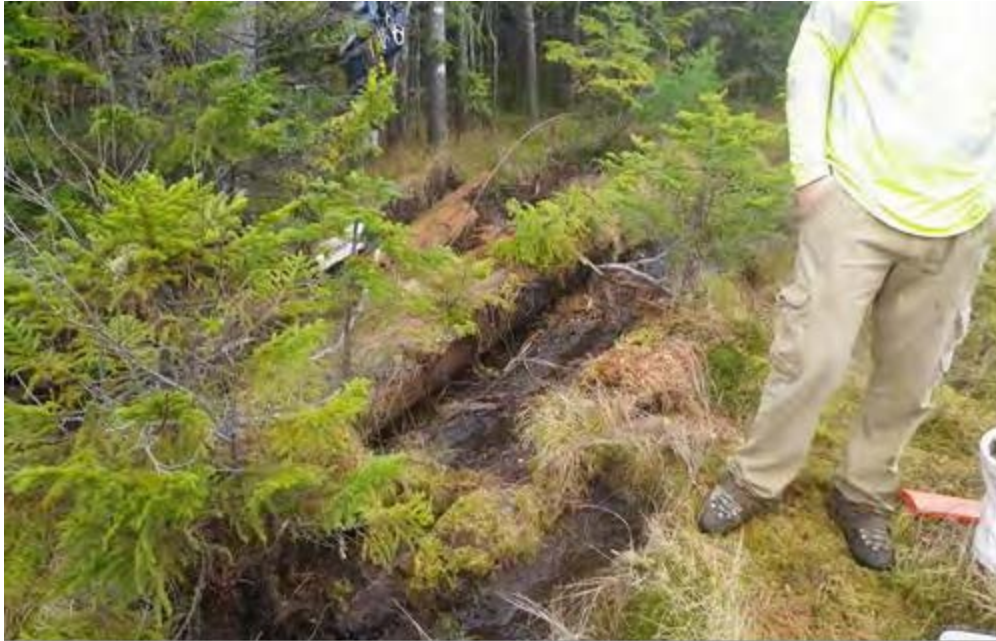
Area at #264 post removal

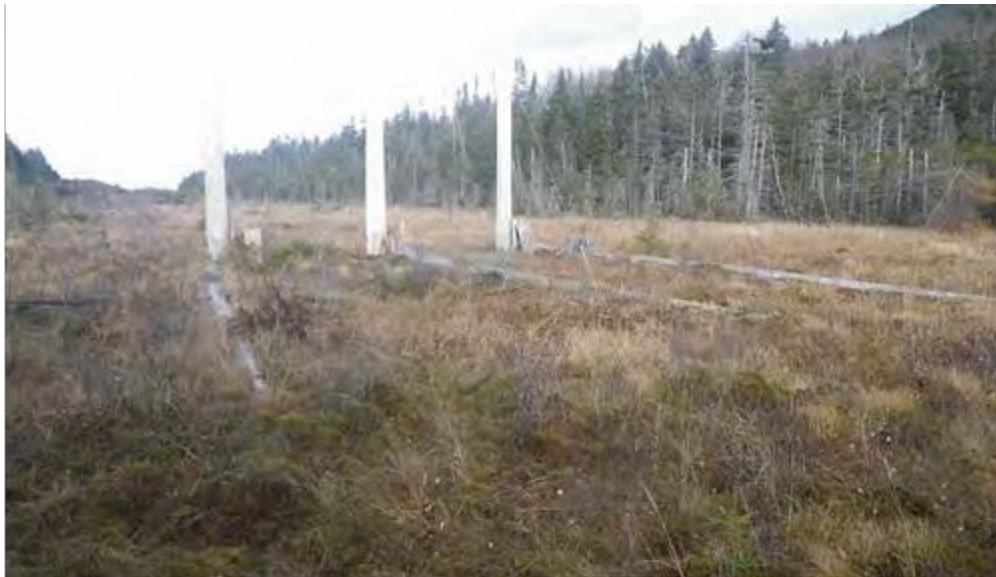
November 3, 2015 – Activity today commenced just south of the Easton town line at Structure 264 and continued to Structure 257. Poles were not removed from Structures 251 – 256 as they were submerged in the peat of the bog, and we felt that removal would cause unacceptable adverse wetland impacts. Additionally, we felt it would be best to leave 3 poles within the wetland near Structure 264 because of adverse wetland impacts.

Poles left in wetland near structure 264 to avoid wetland impacts – 11/3

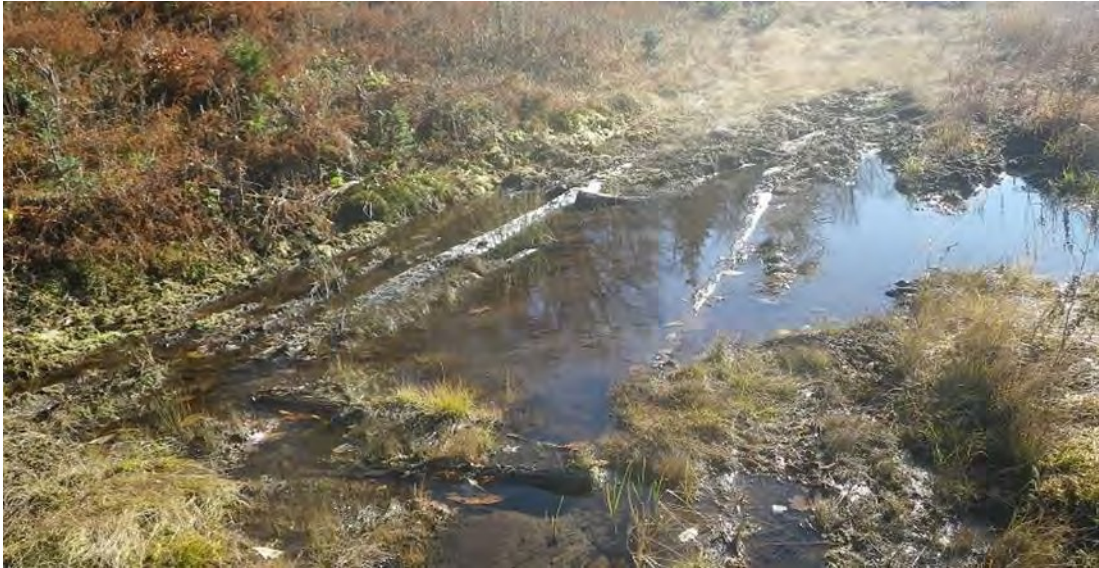
November 4, 2015 – Work returned to Structure 234 today, and progressed to Structure 226. A total of 19 poles were removed today, plus 2 cross arms and a number of partial pole sections. One pole and 2 pieces were left in the wetland near Structure 230, part of a cross arm was left at #229, and 2 poles were left between #227 and 228.

Poles at 227.5 – not removed 11/4

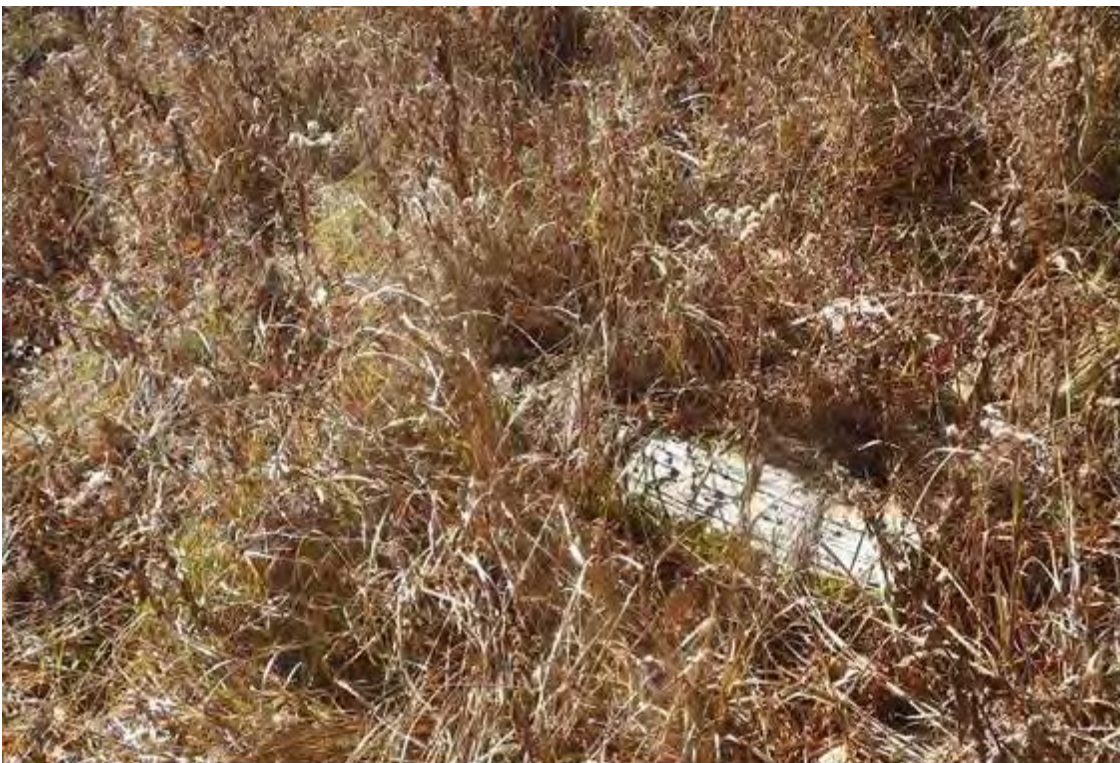
Pole near Structure 230 not removed so as to not adversely impact wetland – 11/4

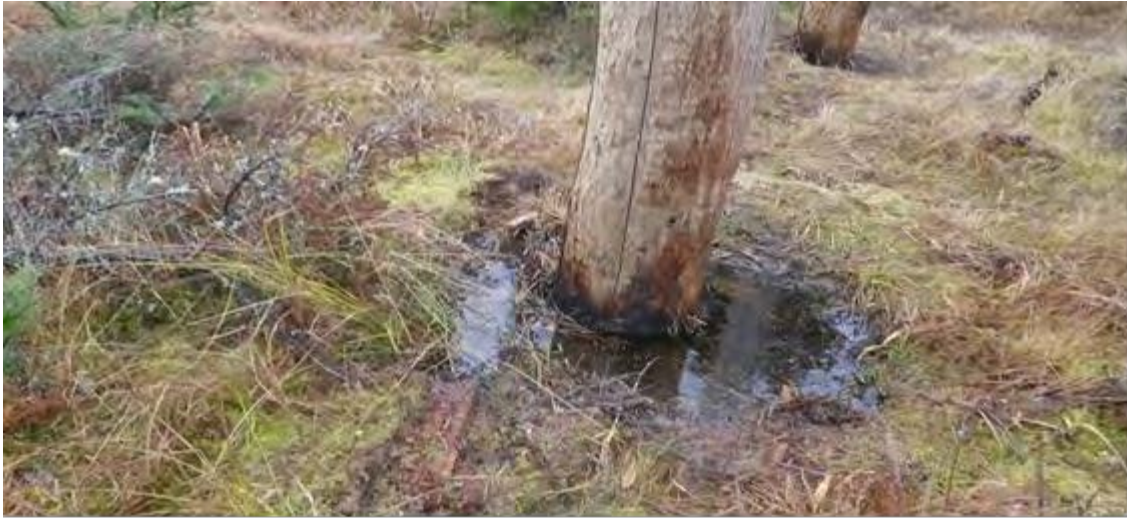
Approximately 16 poles, and most of 3 cross arms were removed today. Part of 1 cross arm was left at #224 due to adverse wetland impacts that would likely be caused if it were removed.

#224 cross arm not removed to reduce wetland impacts

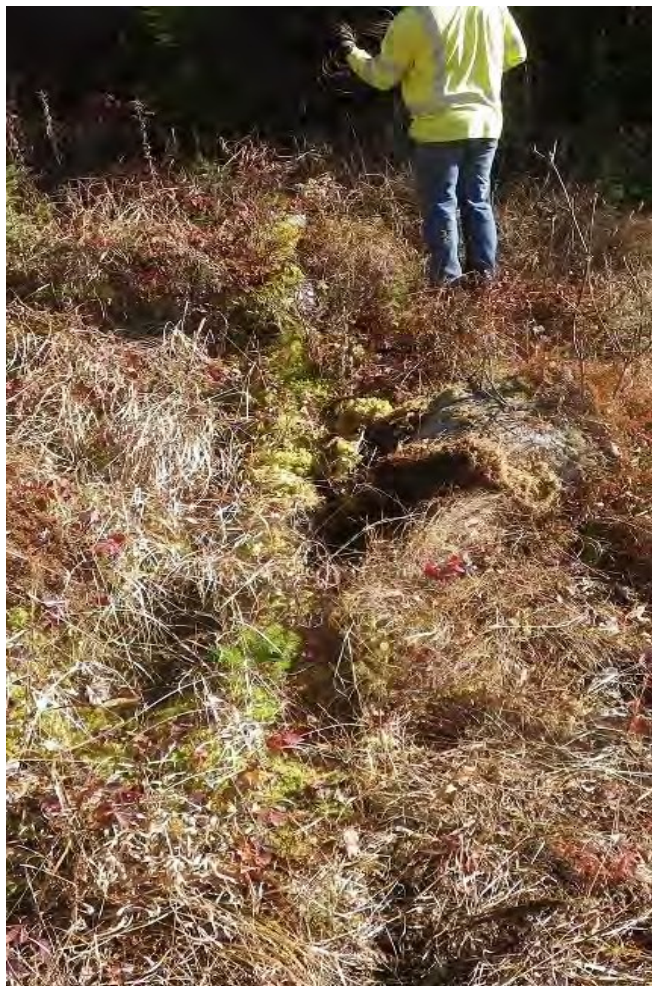
We counted approximately 30 poles removed along with 4 cross-arms and various pieces of hardware. One pole was left in the wetland at #218, and two pieces were left in the wetland at #214, as removal would have resulted in adverse wetland impacts.

Pole left in wetland near #218

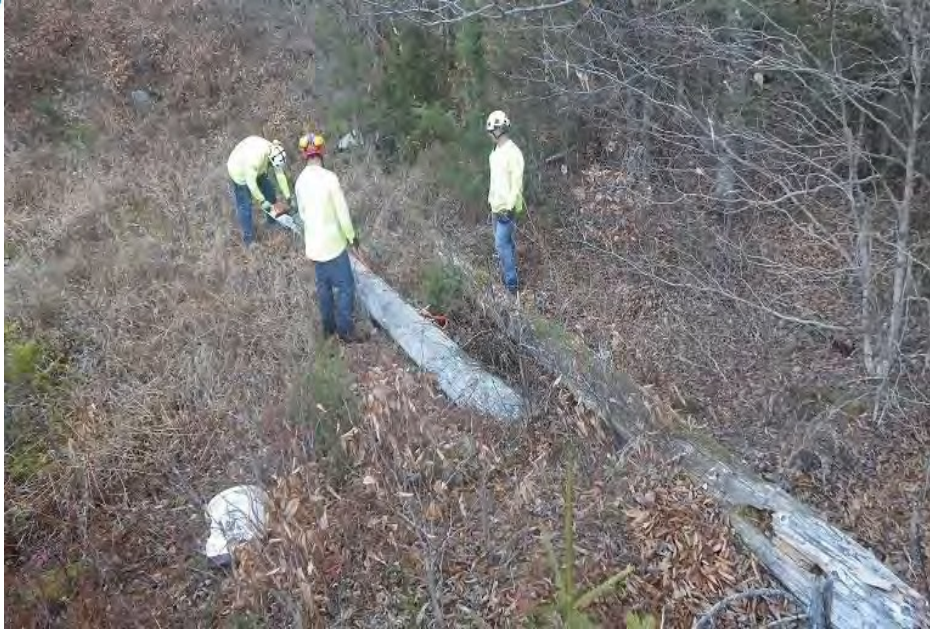
Poles at #214 prior to removal

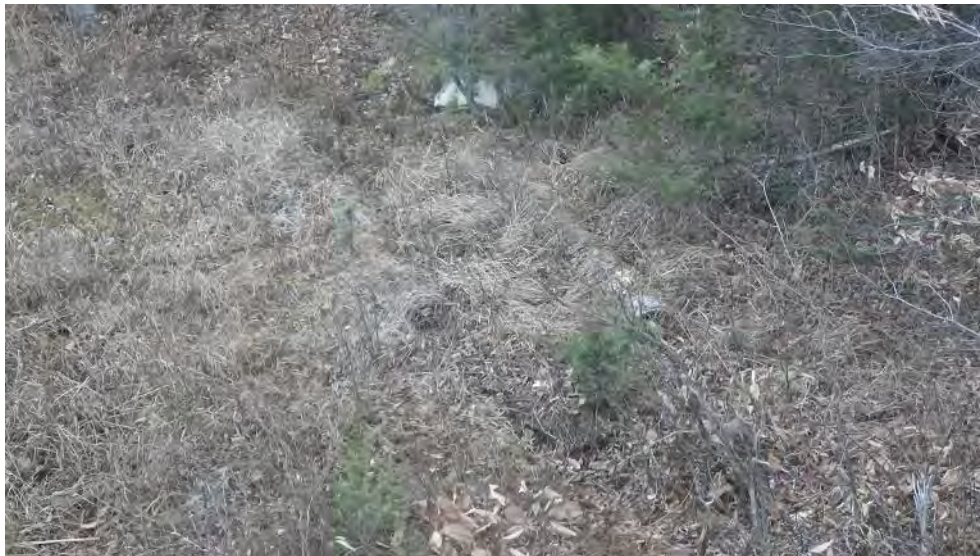
Poles at 214 following removal

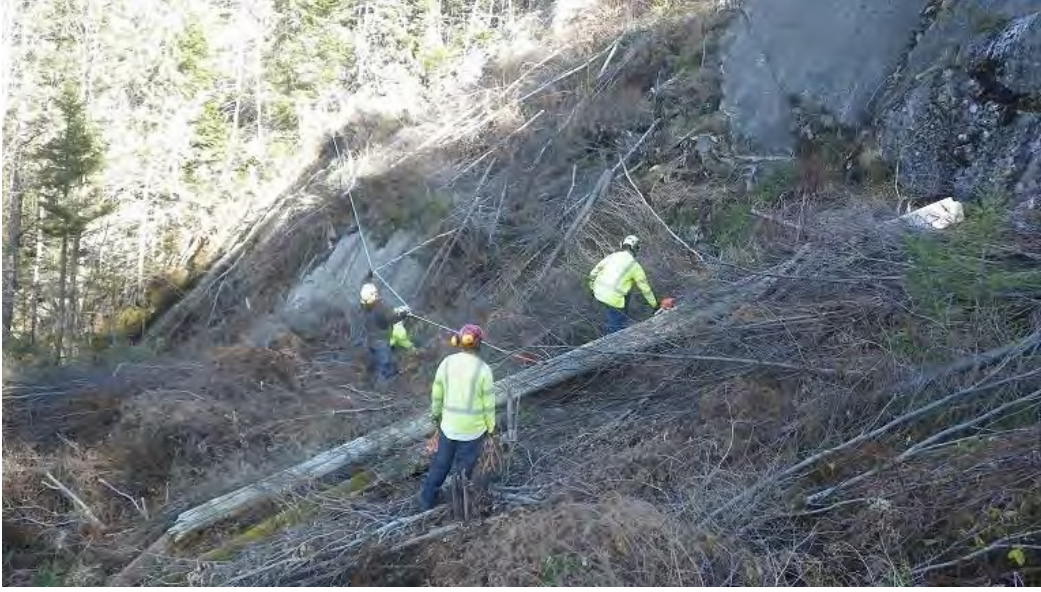
Work on the upper Easton stretch was complicated by tough work conditions. The downed poles at #267 were located both at the top of and at the base of a cliff, with poles buried in the brush. Please note the attached photos. The poles at #268 were located over the side of a bank, perhaps 30 or more vertical feet below the structure. The poles at #270 were located along the slope of and at the base of a ravine, and were also partly covered with brush.

267 base of cliff

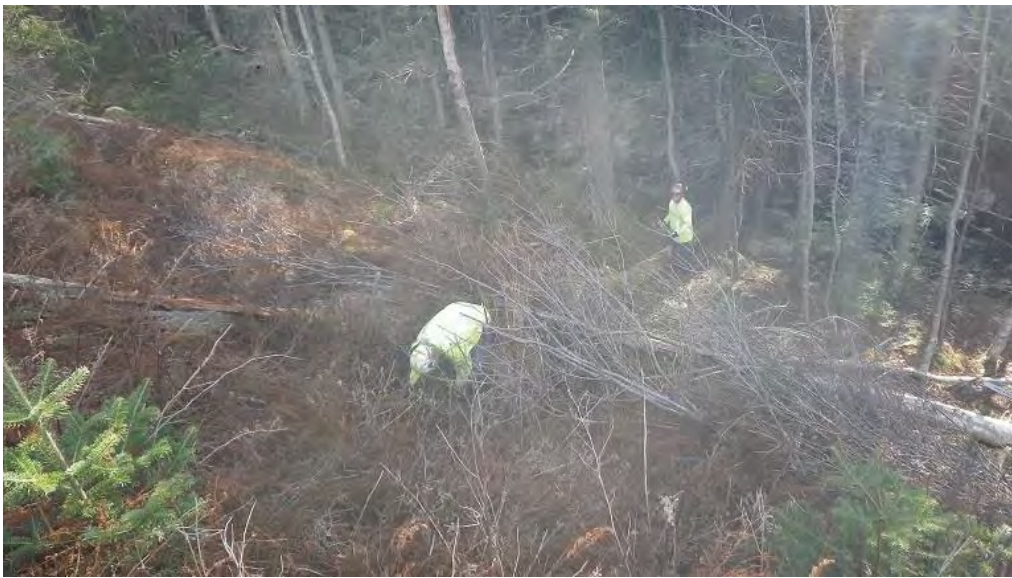
Near 268 - base of slope

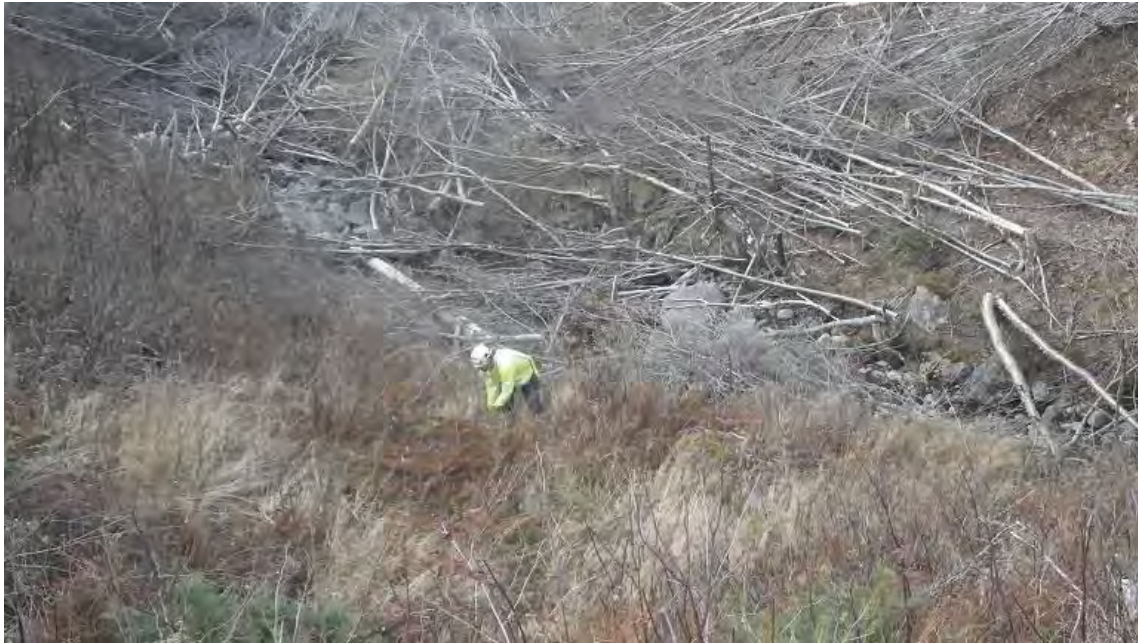
Near #270 base of ravine

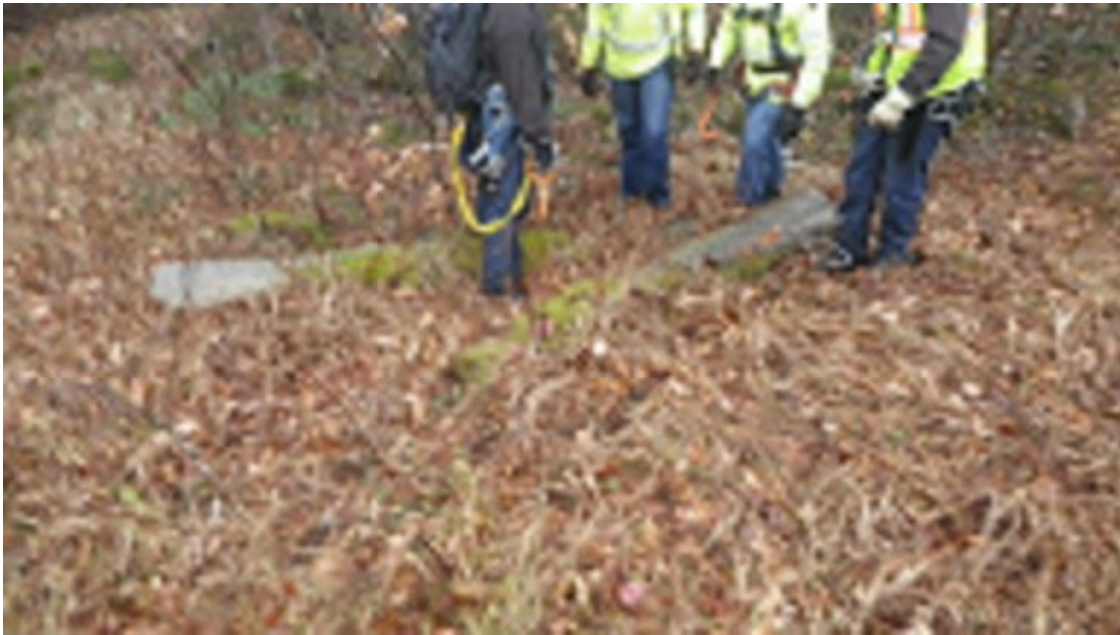
Near #273, poles on surface, removed from wetland

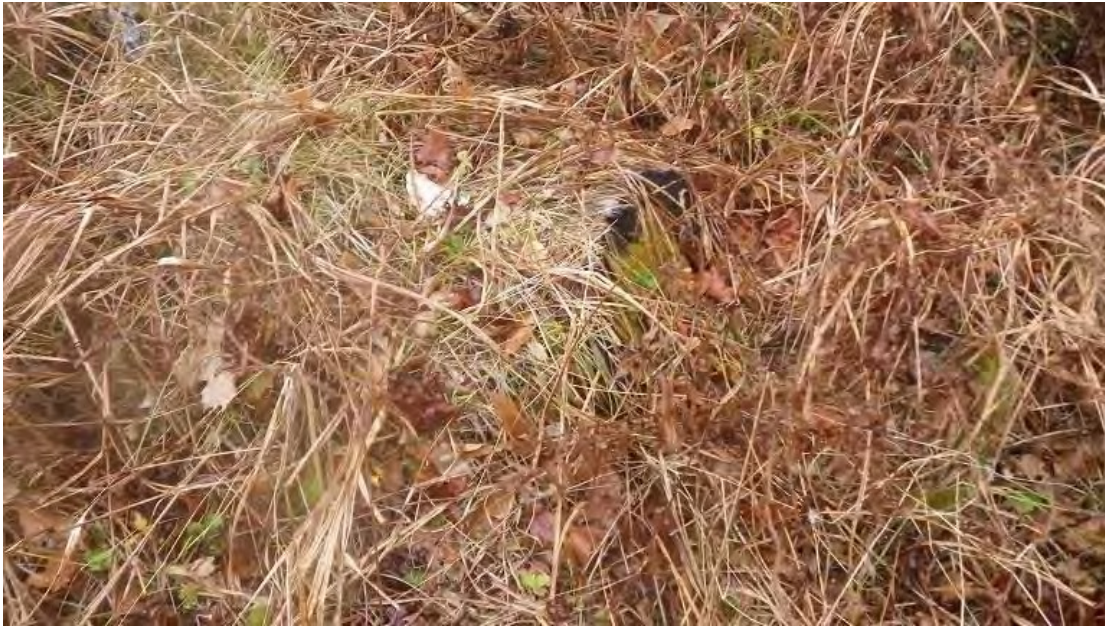
#273 – pole piece buried in wetland, not removed
