Kelsey Notch Trail Environmental Compliance Report 2018

Overview- The Department of Natural and Cultural Resources is required to complete and submit an environmental compliance report to CORD annually. This report is a requirement of the conditional approval to keep the Kelsey Notch Trail open.

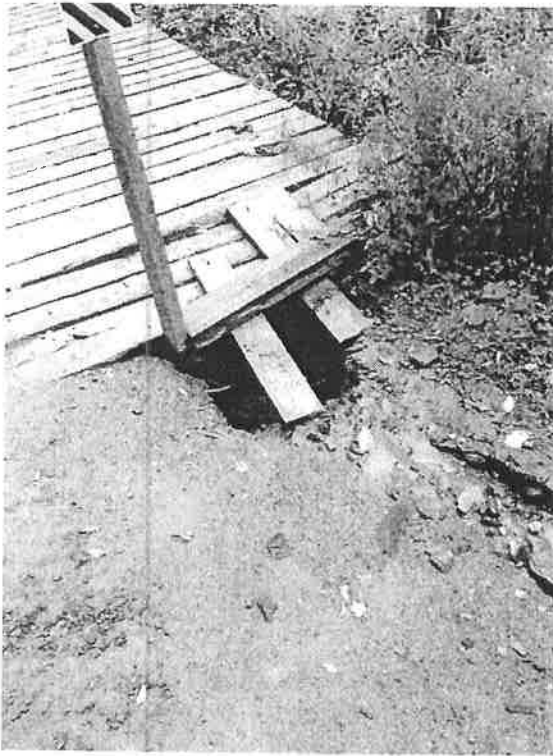
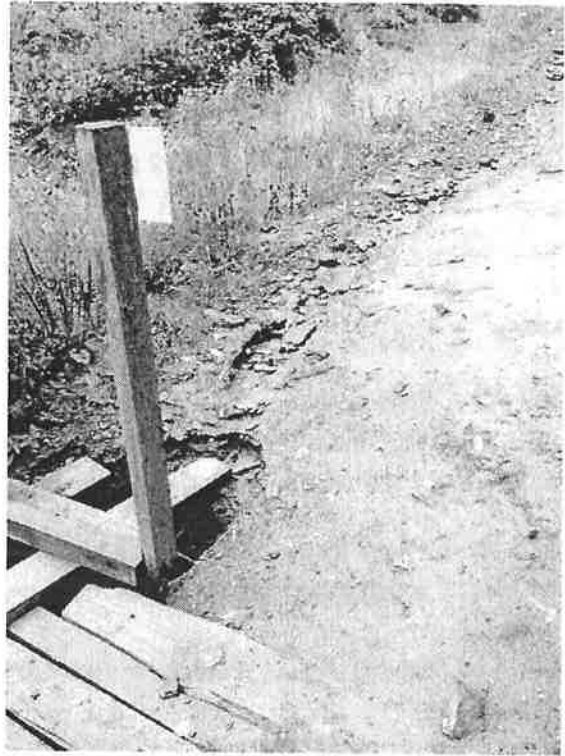
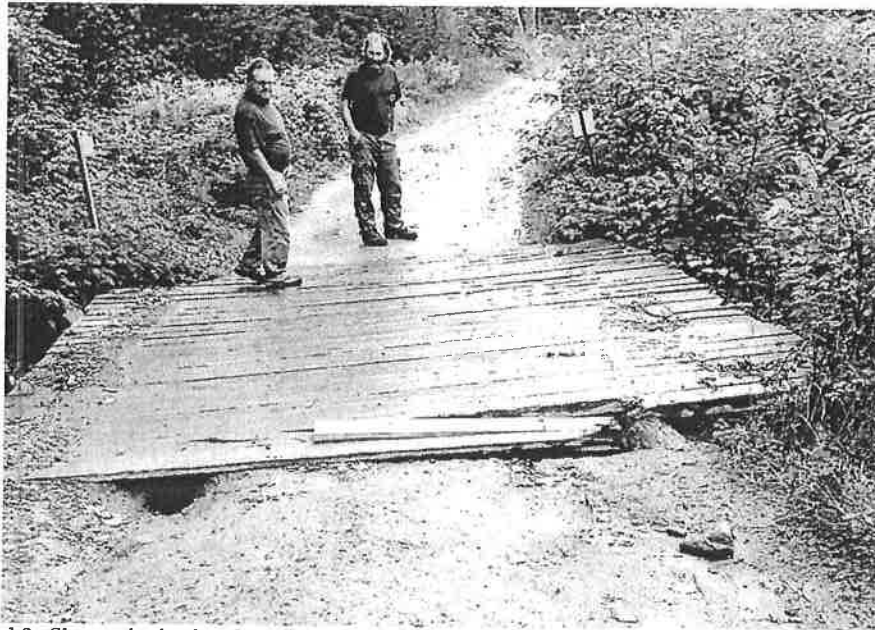
Clint, Chris Holt and Maggie walked the trail on September 9, 2018 to check the trail for any issues. We walked the first section that goes toward the northwest toward Diamond Peaks. There was some erosion on the trail, but just surface erosion. The water didn't seem to be getting into any of the water courses. We located places where there should be additional culverts added. The bridge decking was beginning to be a problem. The decking was broken in some spots on the two bridges and the approaches to the bridges were starting to erode.

Figure 1, 2 and 3- Shows the broken boards on the bridges and the eroding approaches.

- The bridges need to be re-decked to alleviate safety concerns
- Fascia boards should be added to the bridges to eliminate sediment getting into the brooks.

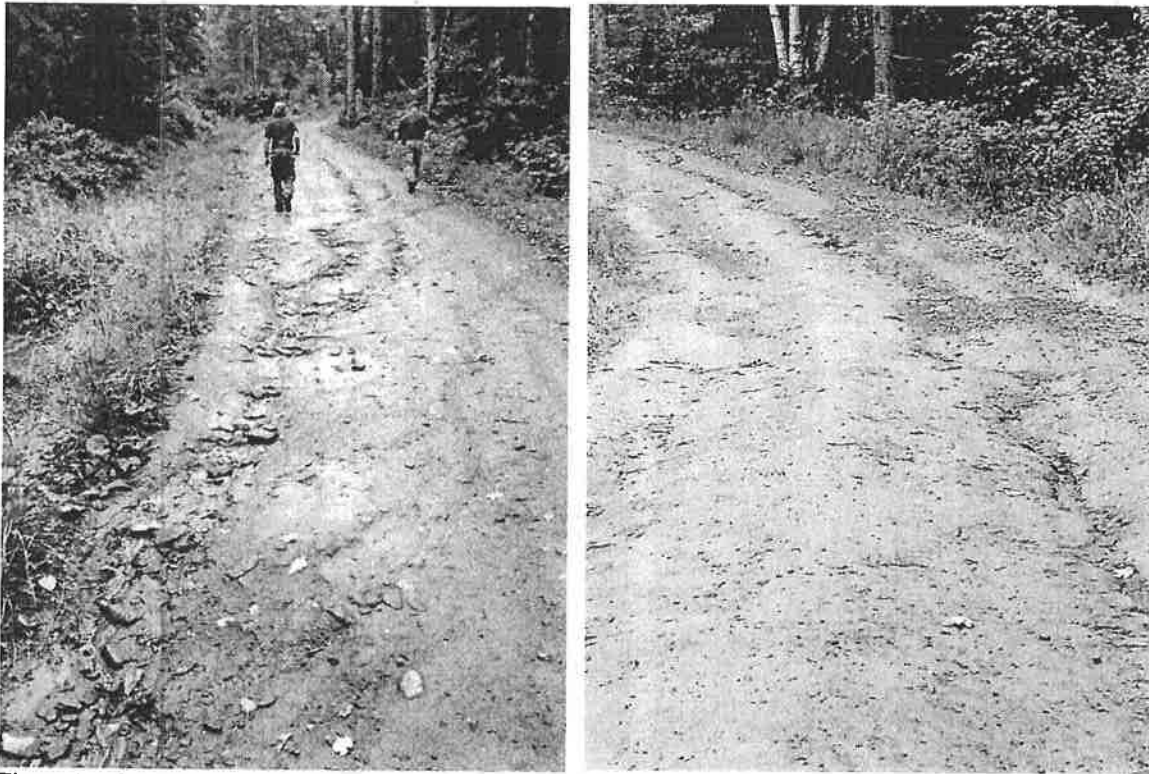
Figure 4 and 5- Shows some of the wear on the trail heading toward Colebrook.

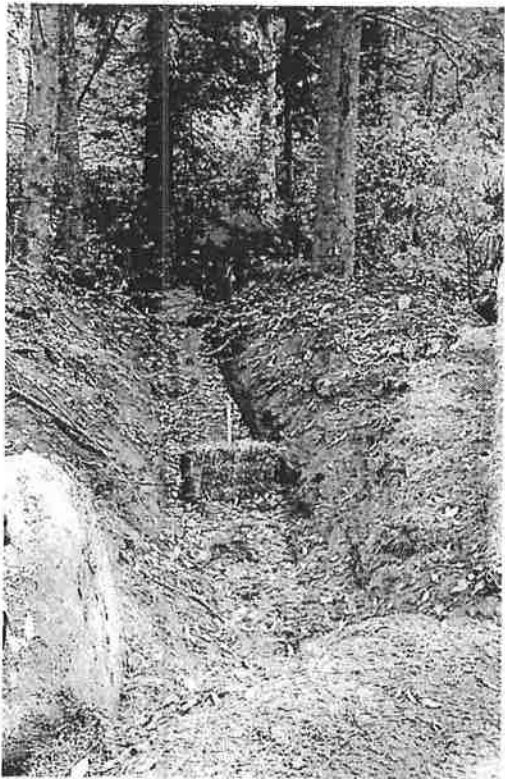
Section 1- The section of the trail that was monitored first was the trail that heads northwest toward Colebrook and Diamond Peaks. Five new culverts had been recently added as well as the trail shaped up. Installation of these new culverts was very good; they had good exits and headers. Most of the new culverts had already been seeded and mulched but there were 2 spots that needed additional mulch. The bridges still need to be re-decked and fascia boards should be added to eliminate silt from entering the brooks.

Figure 8 and 9- Picture on right shows the good exits of the newly installed culverts. Picture on left shows the rubber water diversion devices installed.

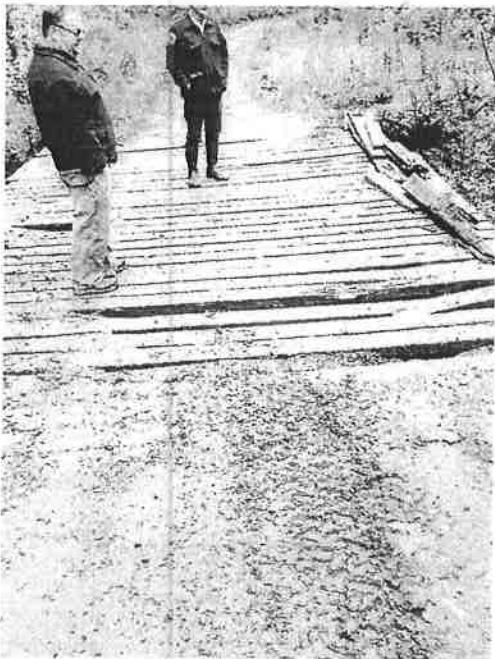
Figure 10- Depicts the repaired approach to the bridge, however, still shows the decking that needs replacing.

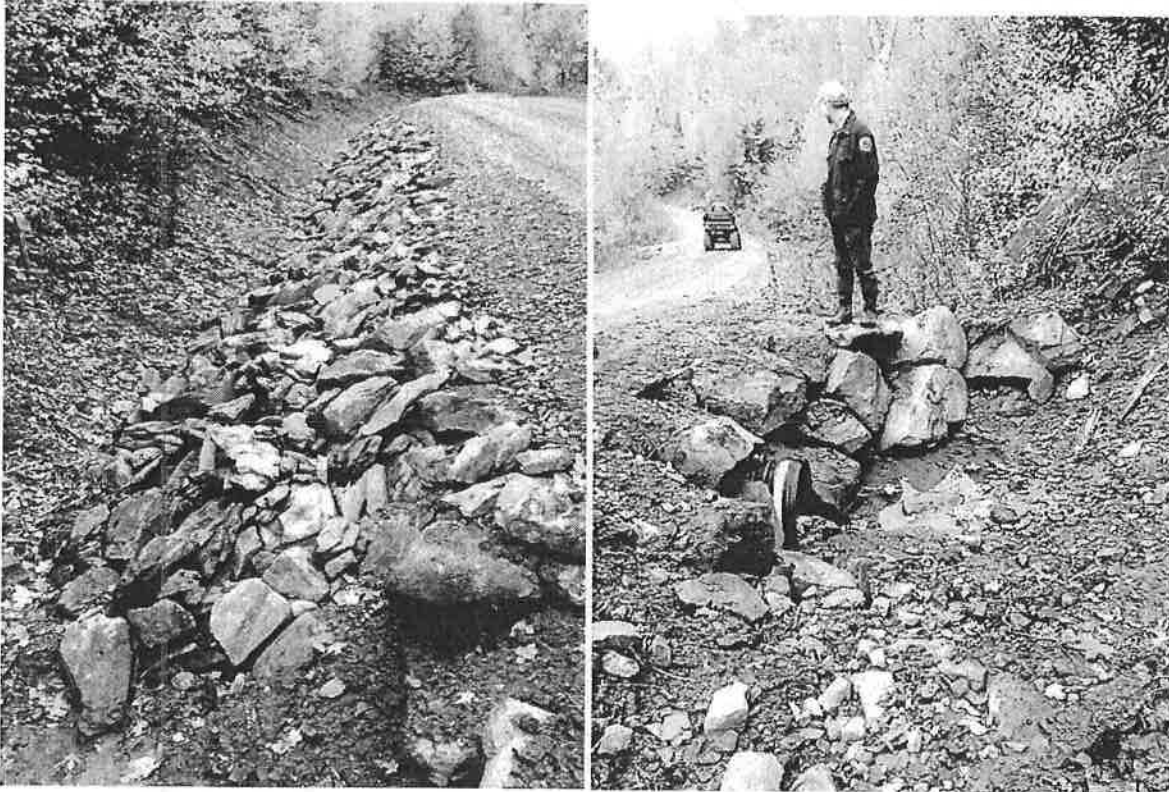
Section 2- Next we headed up toward Kelsey Notch and the boundary line. This main section had been re-shaped and water diversion devices (rubber flaps) had been installed on the main hill. The upper section of trail was currently being graveled while we were visiting. The significant washout that was previously noted from the last visit had been repaired and armored with rip-rap stone, which will help in the future. Four new culverts were added to this upper section above the washout.

Figure 11 and 12- Depicts the newly fixed and armored ditch where the washout was previously. Also shows a newly installed culvert.
