SUBJECT: 2020 NASH STREAM ENFORCEMENT MEMO

SUBJECT: 2021 NASH STREAM ENFORCEMENT MEMO

SUBJECT: 2022 NASH STREAM ENFORCEMENT MEMO

NH Fish & Game - OHRV/Snowmobile Accident Report

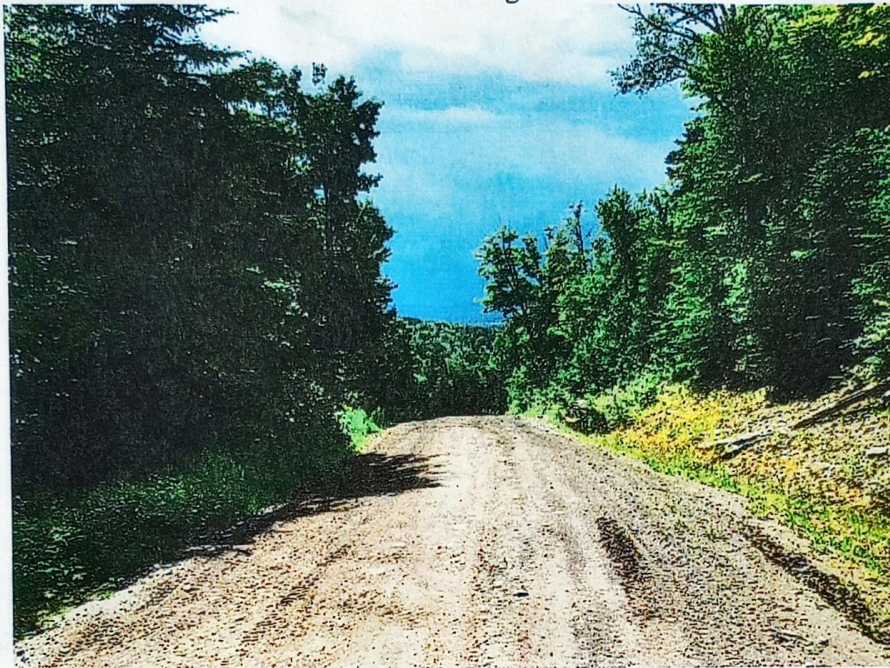
1. Straightaway Trombley traveled prior to where crash occurred.

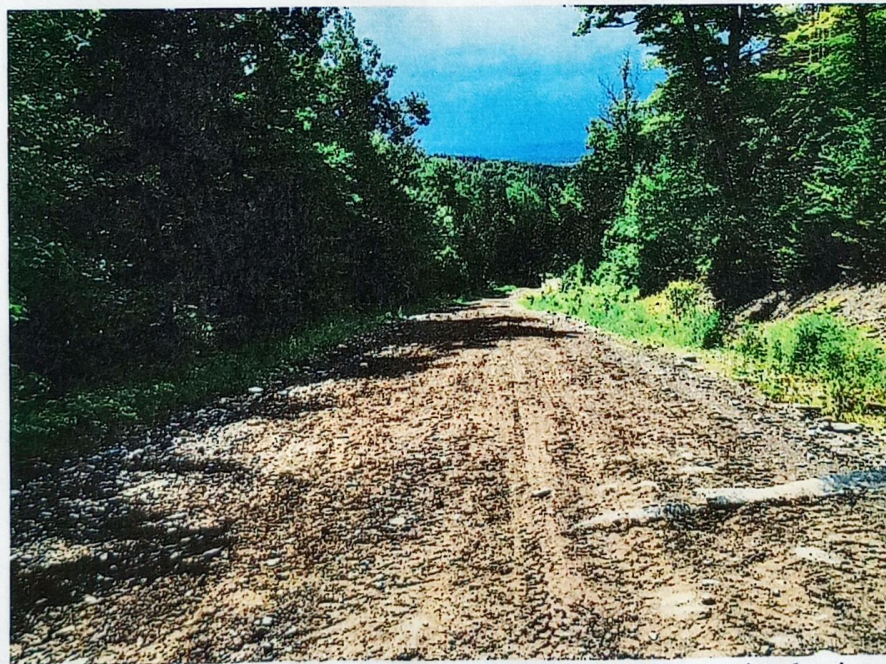
2. Further into straightaway where downhill bumpy section begins.

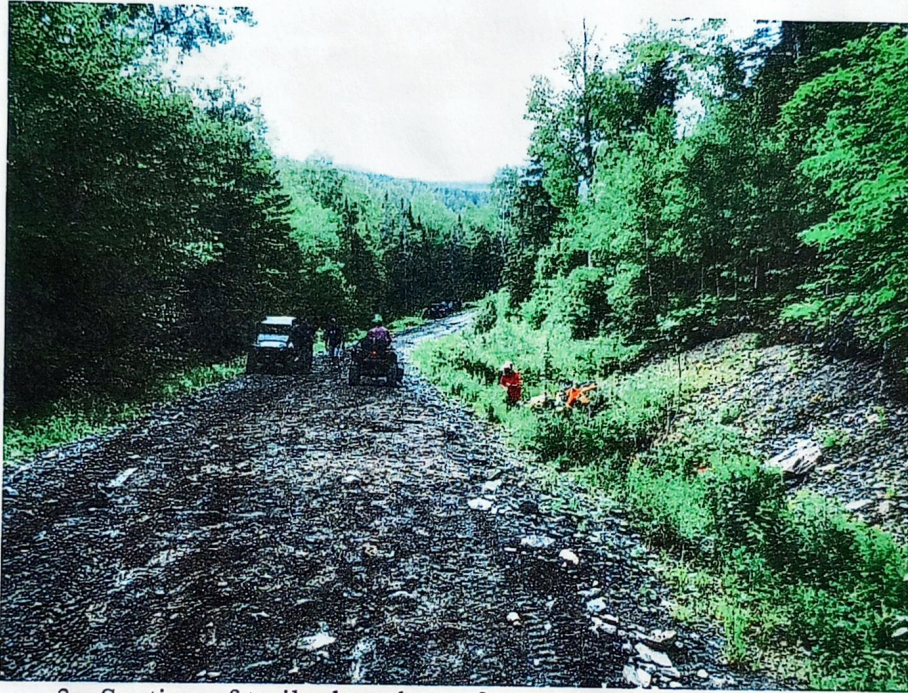
3. Section of trail where loss of control occurred on bumps.

Concluding my investigation in this crash, it was determined that the primary factor in it was unreasonable speed for the existing conditions. Kelliann was operating in heavy rainfall when she encountered a bumpy section of trail that she ultimately lost control in. I believe that her speed, combined with the trail character and rainfall, all played a role in the crash. Kelliann was issued a written warning for this violation.

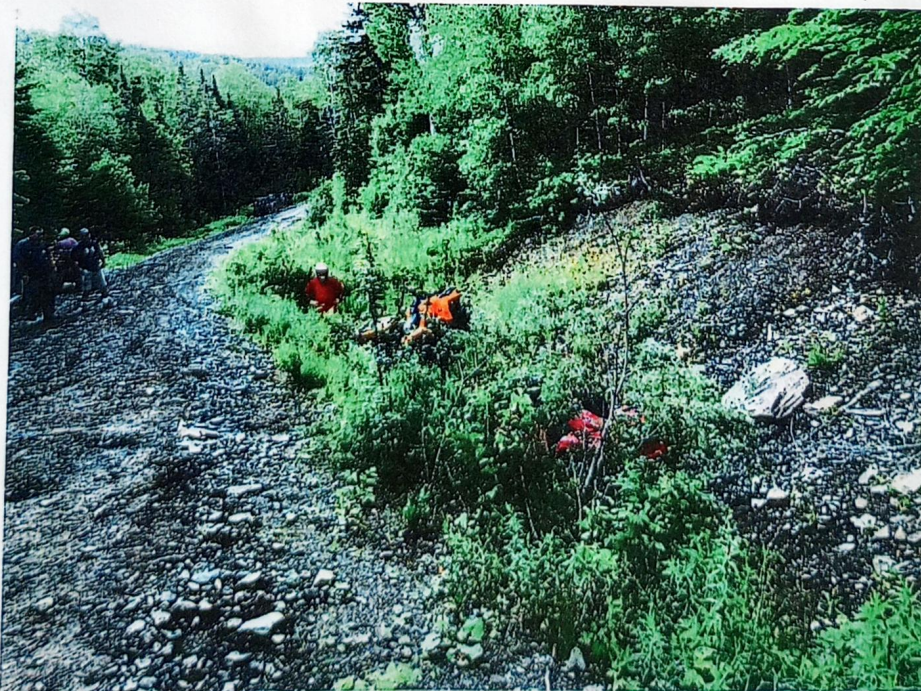
4. Where Trombley traveled off right side of trail and rolled over into ditch.

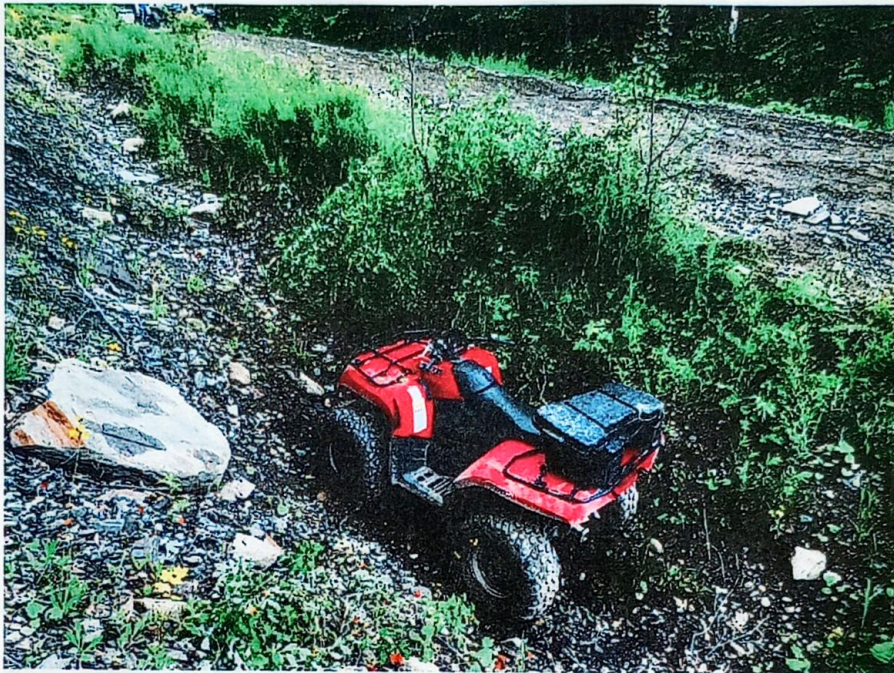
5. Where Trombley's ATV came to rest in ditch off the trail.

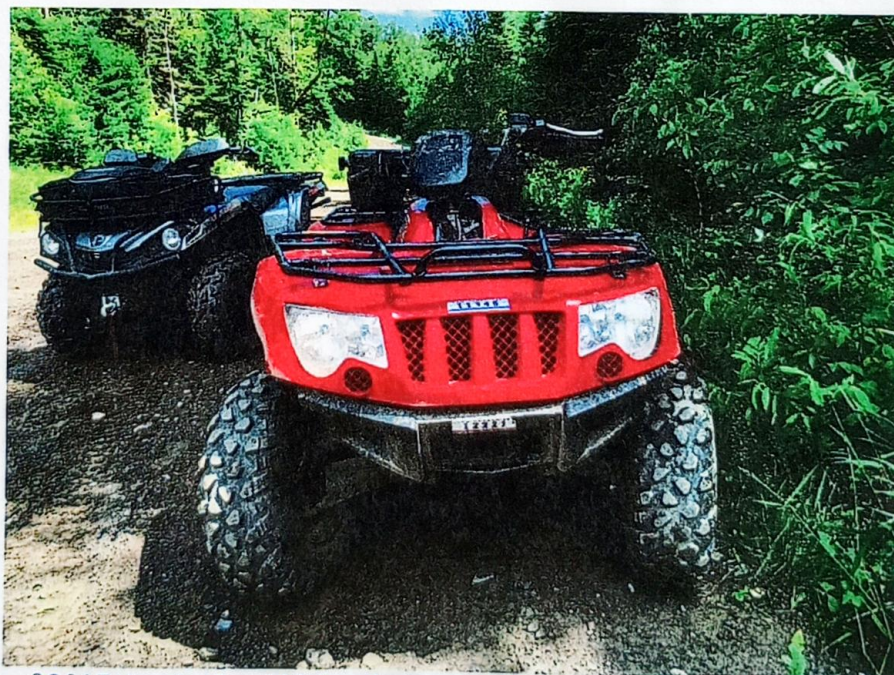
6. Front of 2017 Arctic Cat 500 bearing registration decal # [REDACTED] handlebar damage.

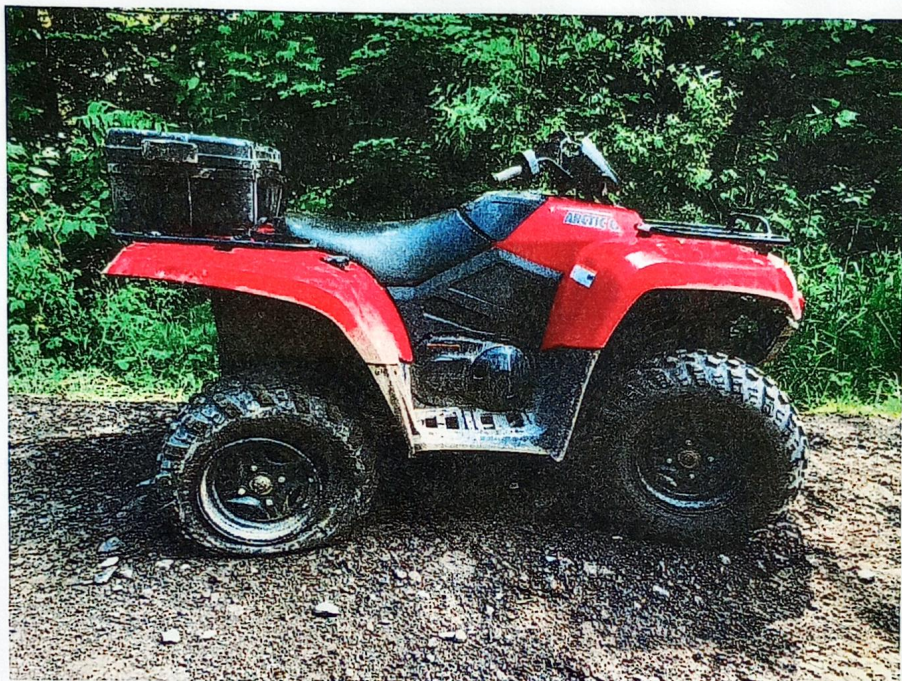
7. Ride side view of ATV; visible damage to rear wheel and tire.

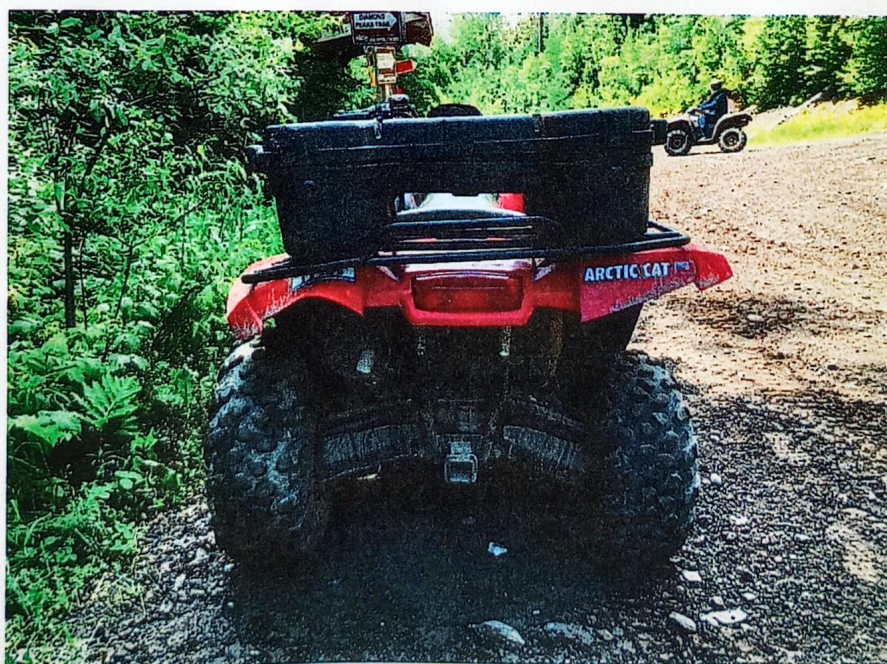
8. View from rear of ATV; visible damage to plastic, rack, and storage box.

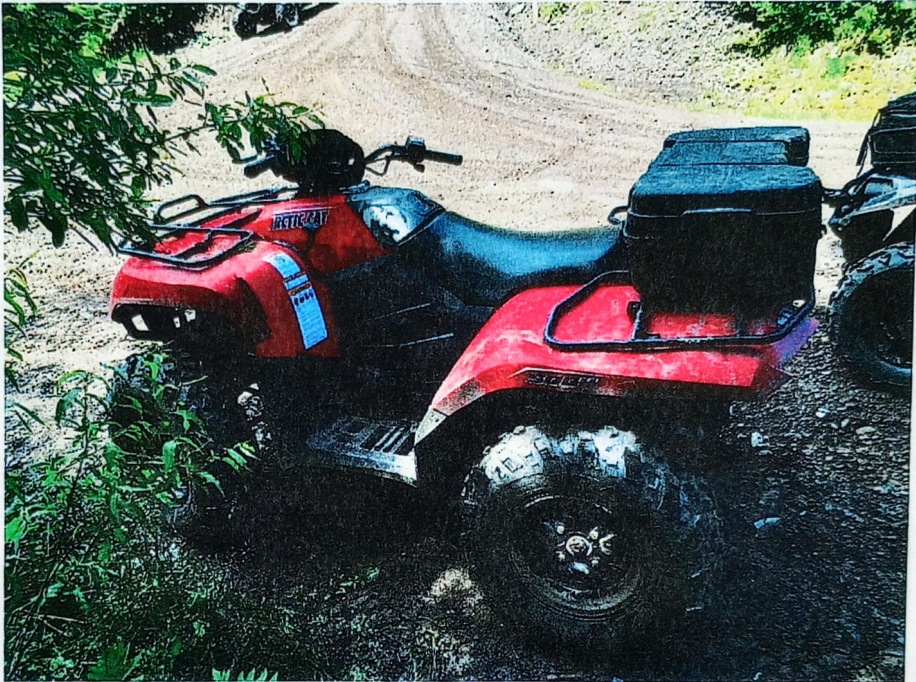
9. Left side view of ATV; visible damage to gauge cluster, racks, and front fender.

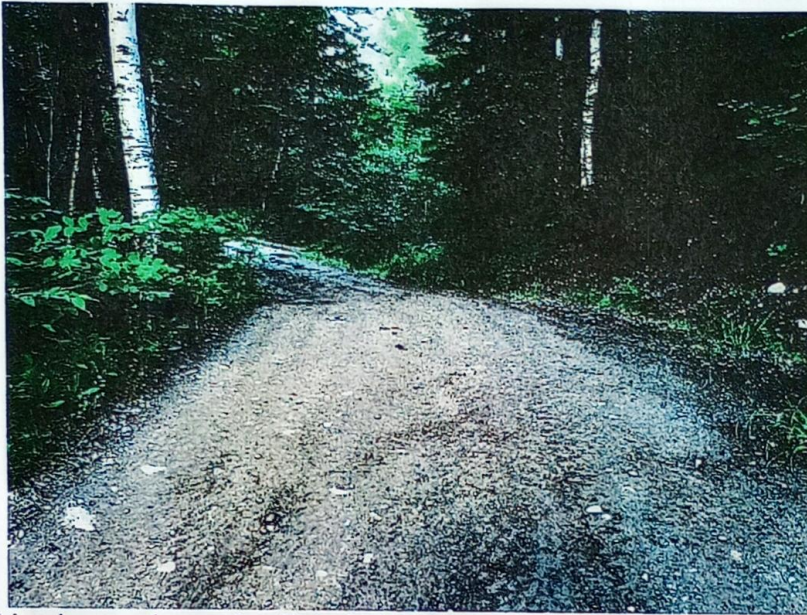
1. This picture shows the direction that Trevor was traveling and the hill that he came over too fast.

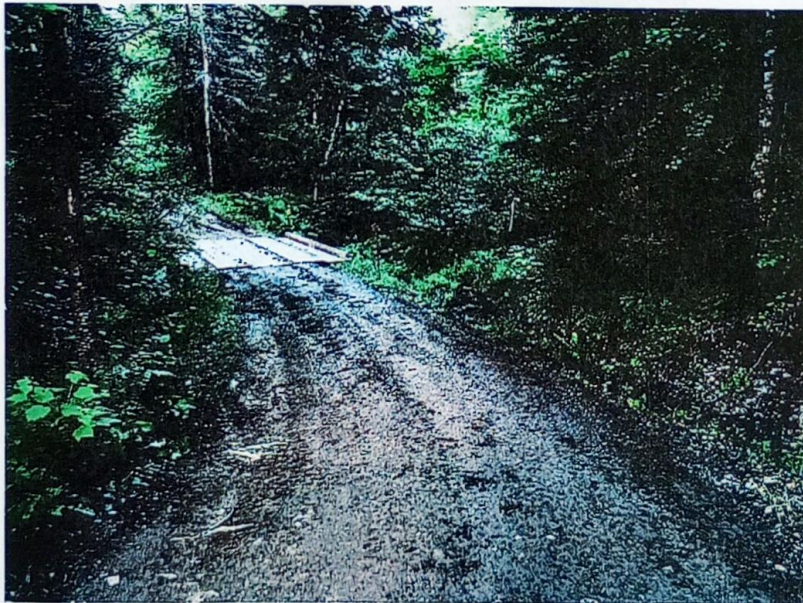
2. This is from the height of the hill showing the right side of the corner before the bridge that Trevor went into. The ditch where his brother Devon's ATV would have been sitting before Trevor crashed into it.

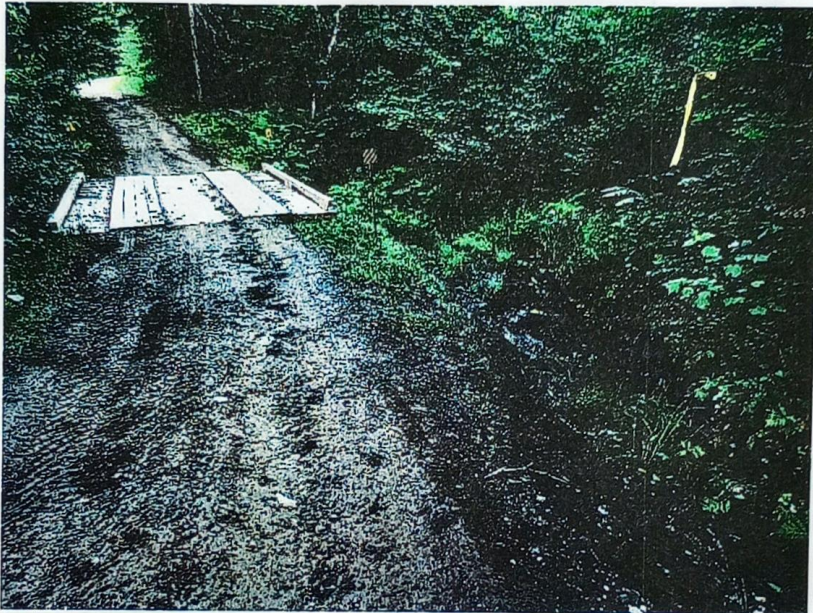
3. This is a closer view of the ditch showing ATV tracks that are consistent with both Rackliff's stories.

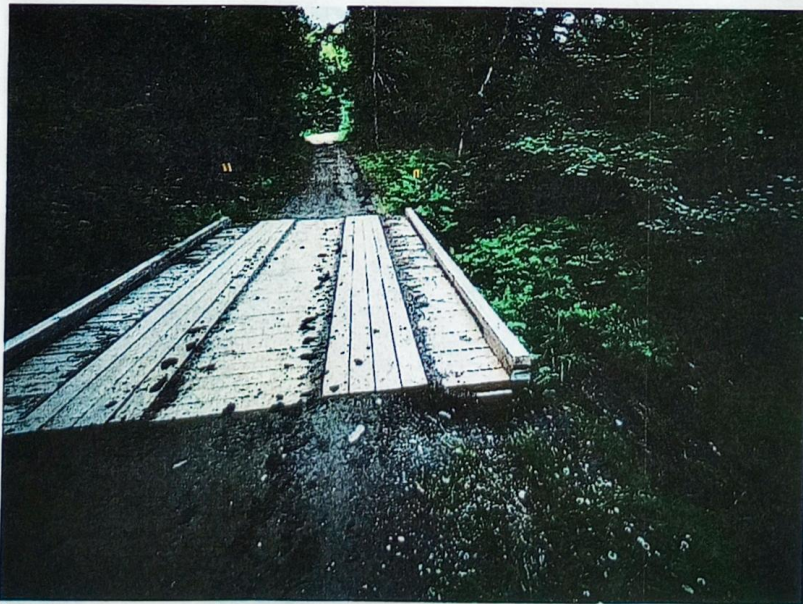
4. This shows the tracks again, well off the trail and into the ditch.

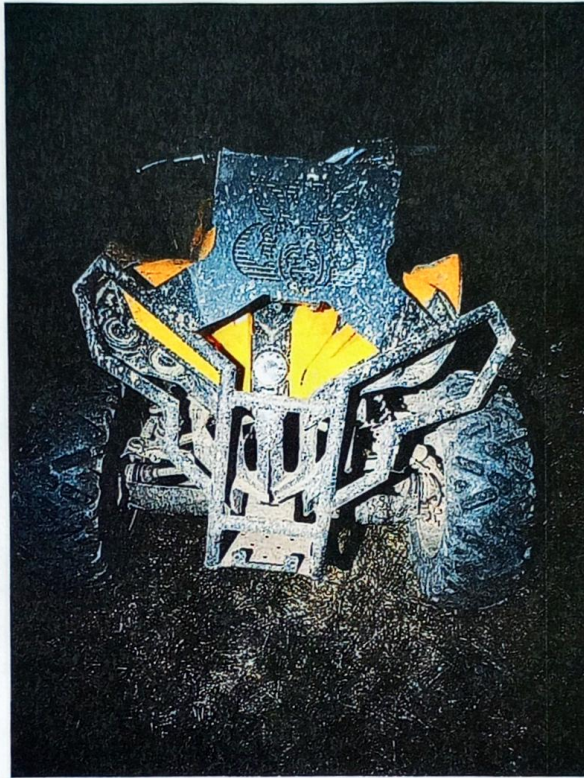
5. Trevor's ATV with no damage to the front. This is also consistent with the Rackliff's stories.

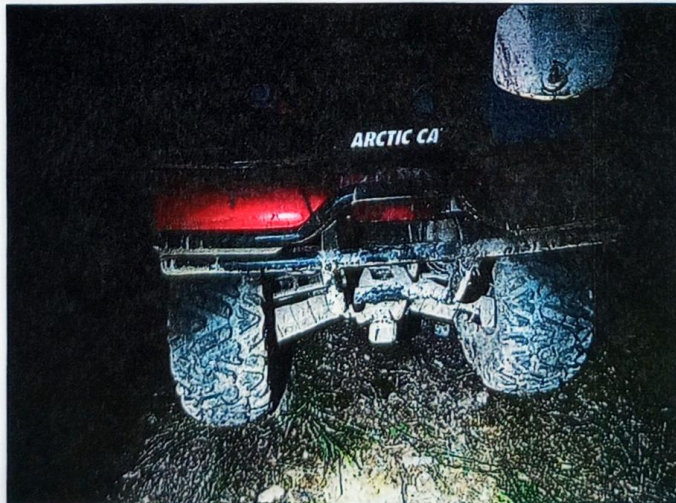
6. The rear of Trevor's ATV. The mud that is cleaned off from the bumper and lower a-arm guard were described as the locations that Devon's head and body struck the ATV.

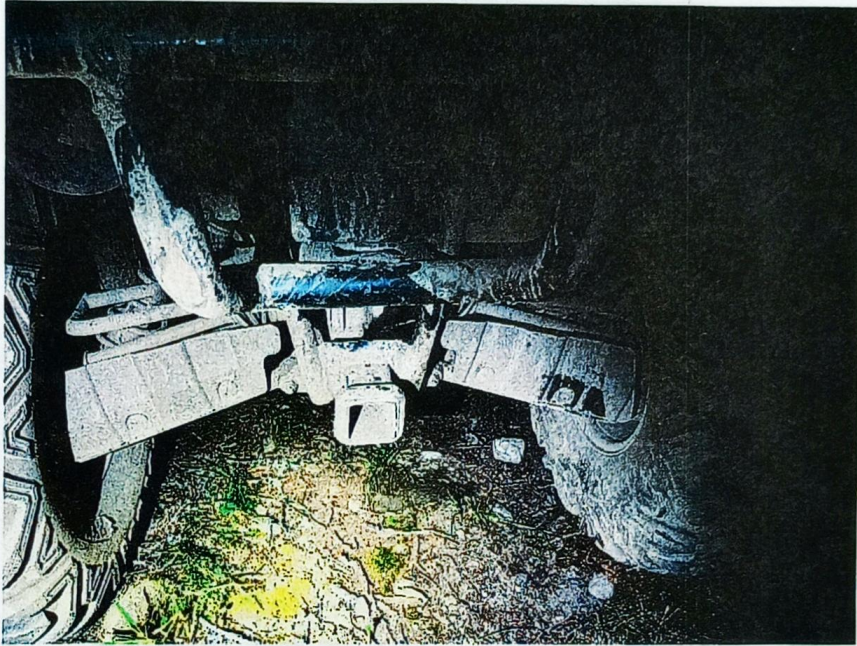
7. Closer view of the described points of impact.
