Kelsey Notch Trail Environmental Compliance Report 2020

Date Reviewed: October 9, 2020

Overview- The Department of Natural and Cultural Resources is required to complete and submit an environmental compliance report to CORP annually. This report is a requirement of the conditional approval to keep the Kelsey Notch Trail open.

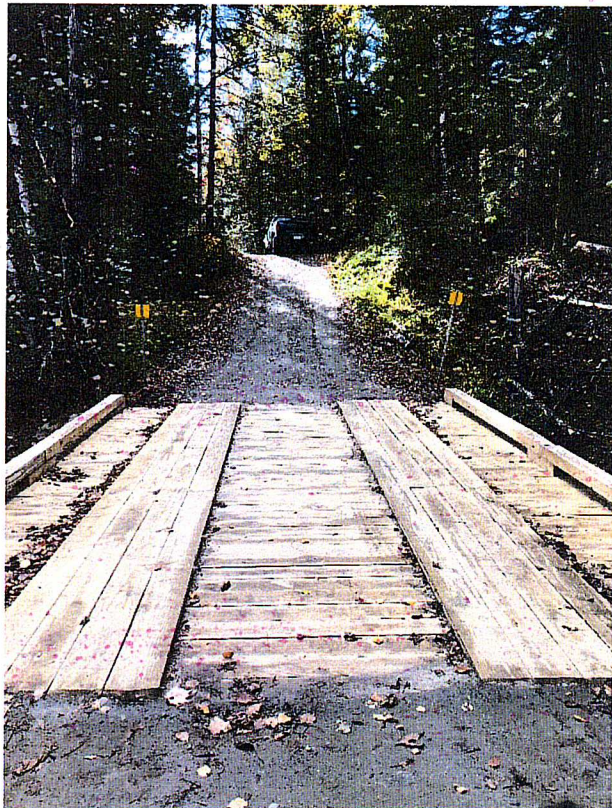
We stopped and looked at the two bridges nearest to the boundary and entrance, which were re-decked during the summer of 2020. These bridges were planned to be replaced in 2019, but the RTP funds were delayed and then there was a delay getting pressure treated wood. The bridges looked good and were built to standards to withhold a loaded log truck.

Figure 1- Newly built bridge

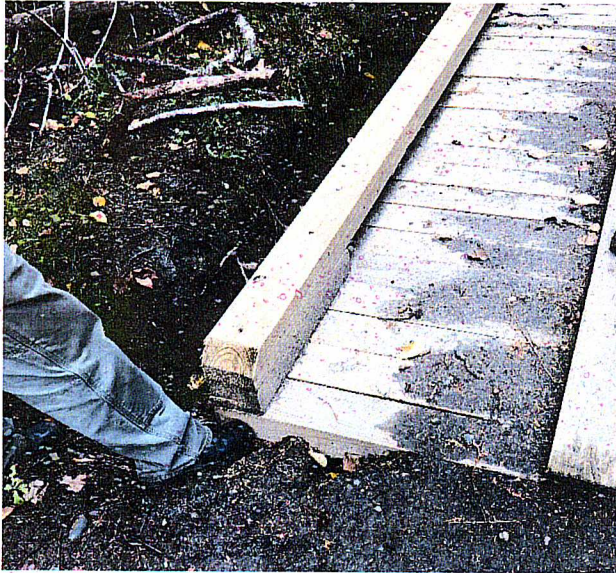
Then, we walked up the section of the trail that heads northwest toward Colebrook and Diamond Peaks. We walked out to the property line. Last year there was a recommendation to re-deck the bridges and add fascia boards to eliminate sedimentation. This project was finally completed after unexpected delays. Three new bridges were installed in this section of the trail, and they looked good. These bridges were made with steel I-beams and should last for a while. There was a small amount of silt washing on the approach to the bridge, hopefully, this does not continue. Some fascia boards seemed to be missing during installation.

Figure 2- Minor sediment washing on edge of bridge

- Treat the invasive species with herbicide to minimize the spread. Flag those areas so that future road work and trail maintenance does not disturb those areas and spread the phragmites.
- Continue to monitor the amount of washing on the edge of the bridge
- Continue to monitor and clean out the rubber water diversion devices

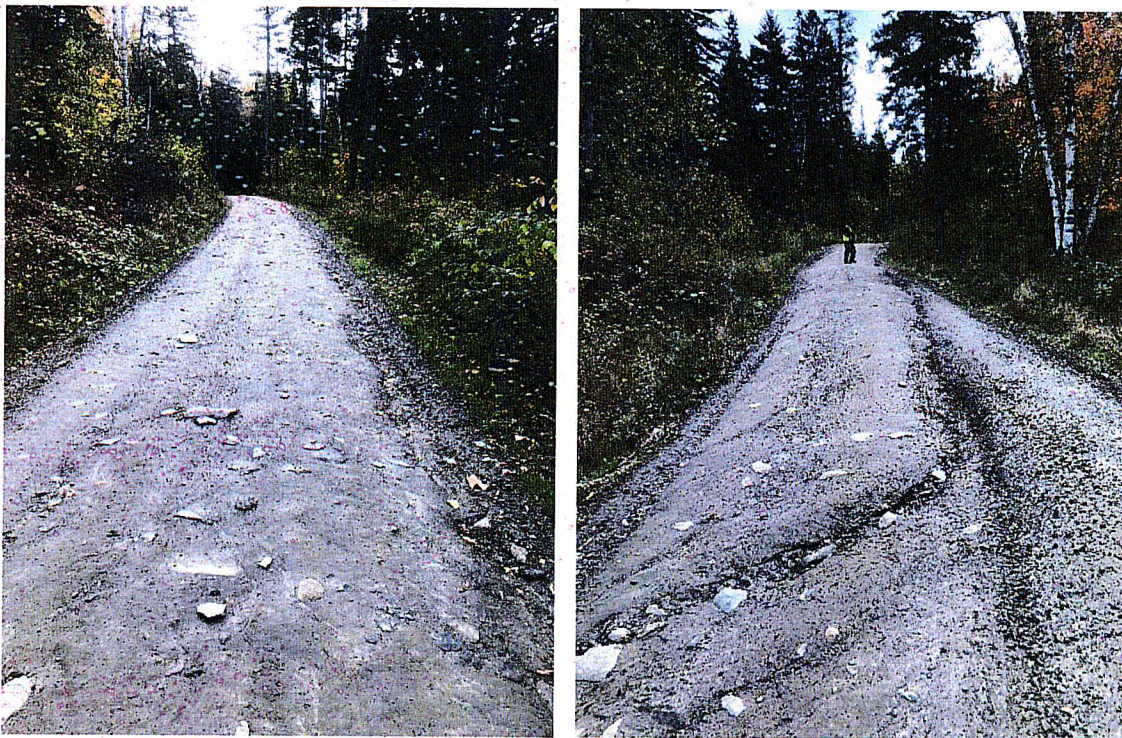
There was wear on the trail toward the end near the boundary line (southwest section of trail) and some evidence of siltation in the ditches but overall this section of trail was in good condition and was a very hard packed trail.

Figure 3- Shows condition of trail

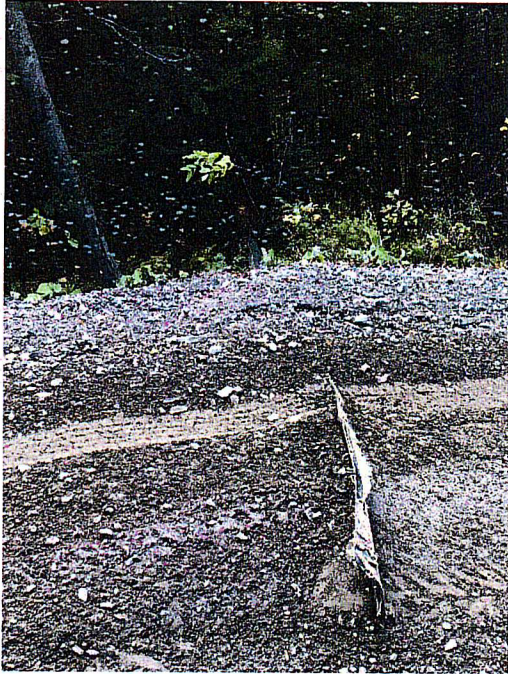
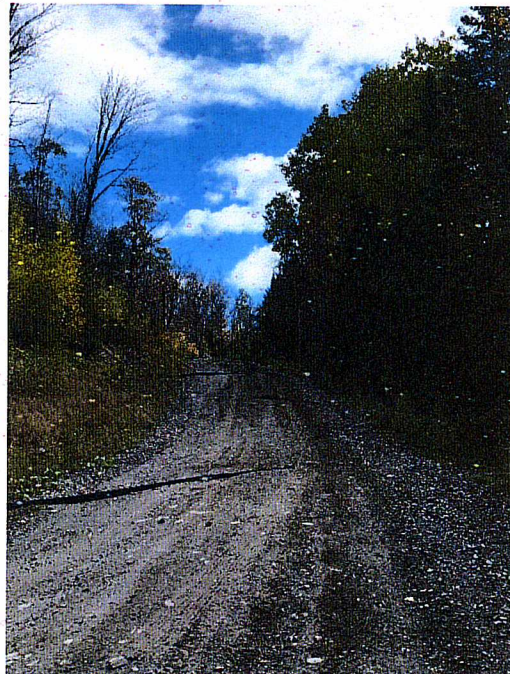
Section 2- Next we headed up toward Kelsey Notch and the boundary line. This main section had been re-shaped, ditches cleaned out and water diversion devices (rubber flaps) had been cleaned out. Due to the recent grading and trail maintenance, the trail was in good condition all the way to the boundary, however the rubber flaps were already filled with sedimentation again.

Figure 4- Showing the water diversion device

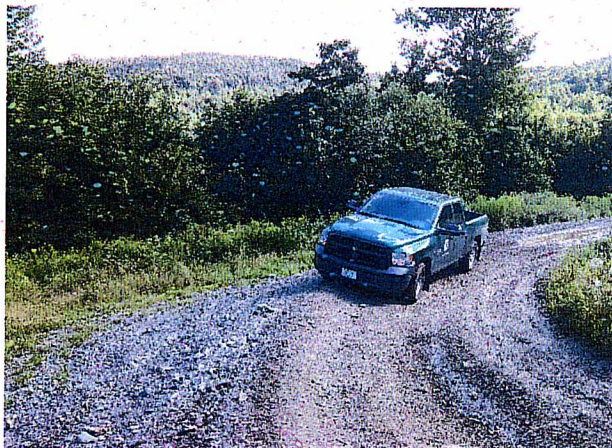
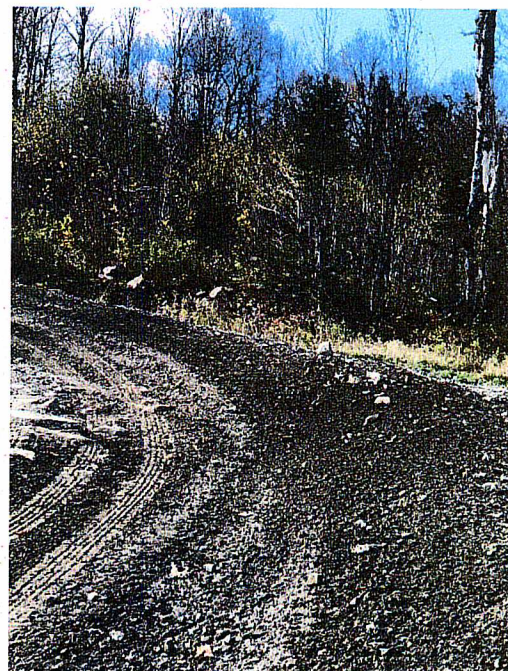
Each year, the sharp corner leading up to Kelsey Notch gets a significant berm. This happens from the dirt and rocks getting kicked out as the OHRVs turn and head up the hill, exacerbated with speed.

Figure 5- Shows berm on corner of trail

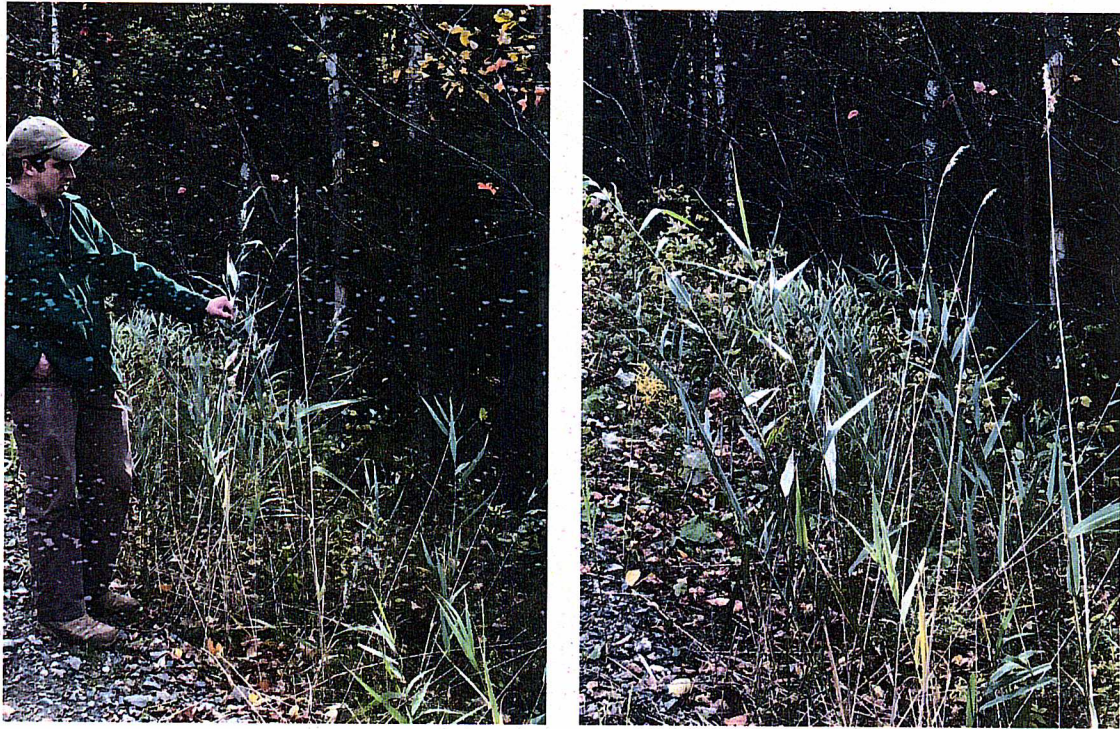
This year, we observed phragmites growing next to the trail in the ditch. This was not observed last year, but it may have been overlooked. There were a few spots that had small populations of this invasive species. It should be treated so that it is not spread. While the source of the invasive is not exactly known, it is logical to conclude that it was brought in either on equipment working on the trail or by ATV's.

Figure 6- Shows invasive species, phragmites
