## **Kelsey Notch Trail Environmental Compliance Report 2021**

**Date Reviewed:** October 15, 2021

**Overview-** The Department of Natural and Cultural Resources is required to submit an environmental compliance report to CORP annually. This report is a requirement of the conditional approval, dated March 29, 2021, for the Kelsey Notch Trail.

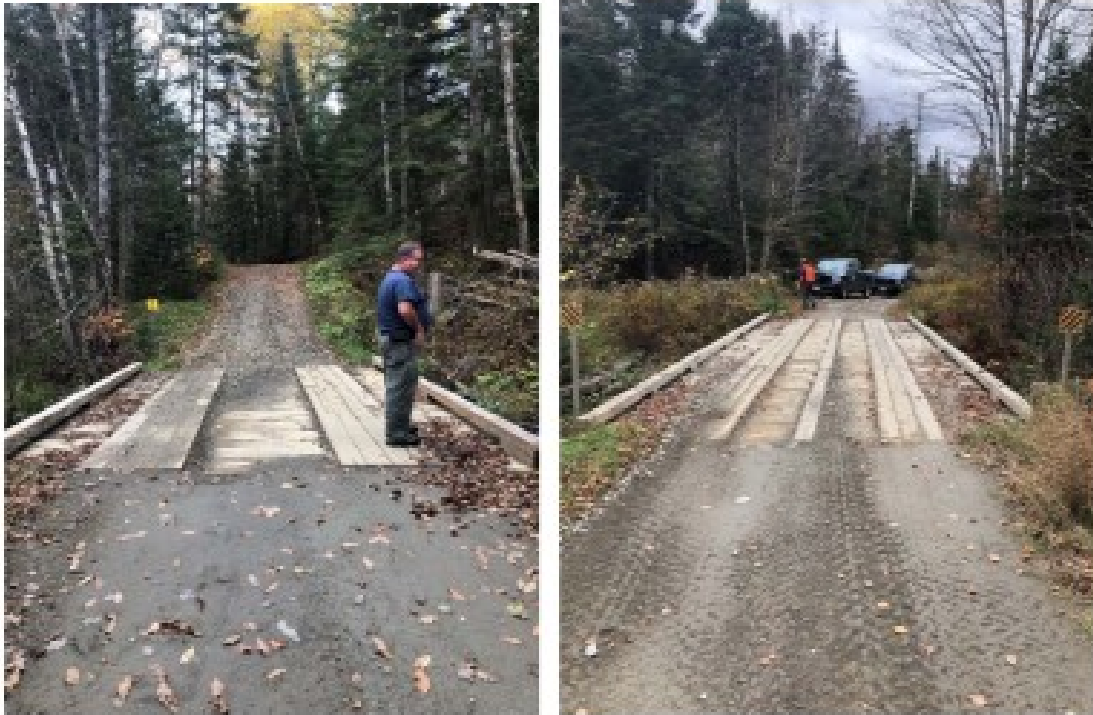
We started by looking at the bridges coming onto the property, as well as the large bridge over the East Branch of Simms Stream (Corridor C-South). All three appeared to be in good condition, and the first two especially since being replaced last year. There was no apparent sediment getting into the brooks that flowed underneath the bridges.

*Figure 2- Shows the condition of the bridges*

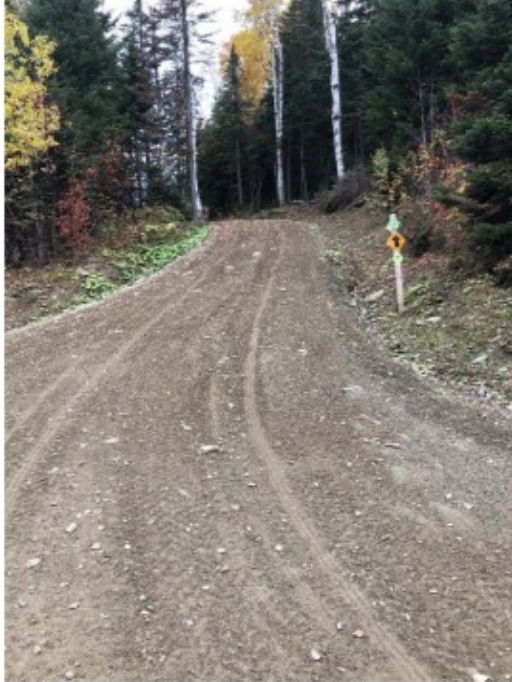
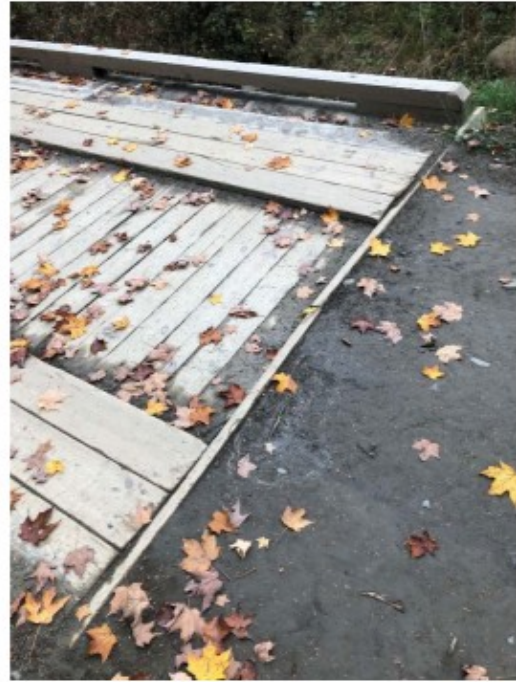
Next, we moved up to the kiosk looking at the hill on the way up. Heading toward Diamond Peaks (Corridor C), we walked out toward the boundary line. This trail was very hard packed. There was minor sedimentation on the trail, meaning there was evidence of sediment that had been washed away from trail but the trail was in good condition. We did not observe evidence of sediment from the trail entering the brooks. All of the bridges had fascia boards added when they were re-decked last year, except one which was noted in the 2020 report. During 2021, the last of the fascia boards were added, and appear to be precluding any sediment from getting into the brooks.

*Figure 3- Shows condition of trail and the newly added fascia boards.*

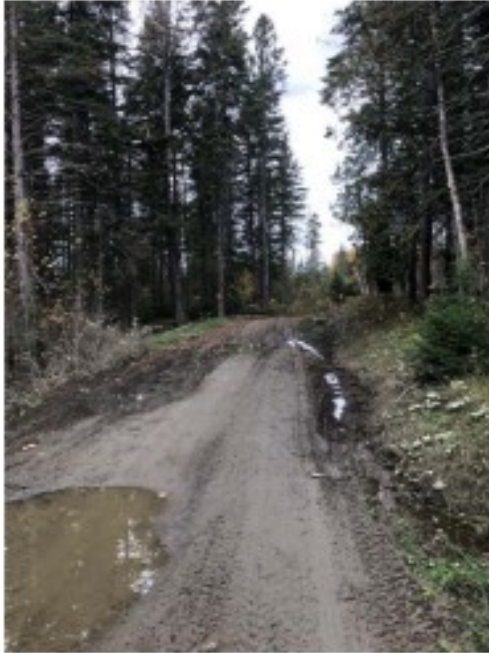
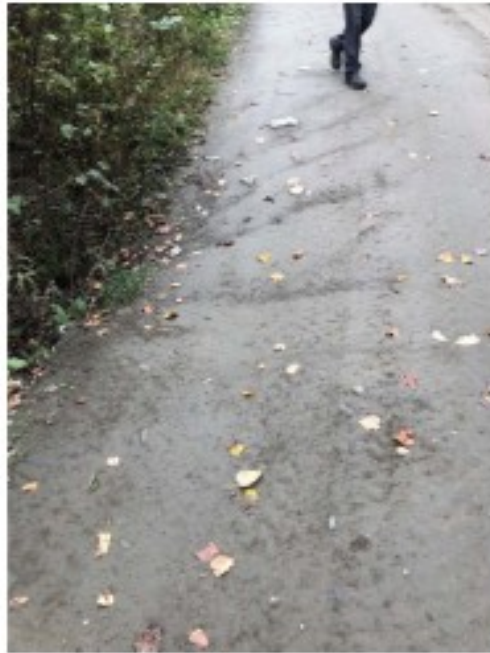
Within Nash Stream Forest, near the boundary line on the trail heading toward diamond peaks (Corridor C) there was a mud hole on the trail and there was some ATV's driving in the ditch, but there was no mud getting into the stream (Figure 4).

*Figure 4- Mud on trail and ATV tracks in ditch and minor sedimentation on trail from water.*

- Fix the mud hole near the property line toward Diamond Peaks (Figure 4).
- Place a culvert before the bridge at the end to address the sitting water near the mud hole (Figure 4) .
- Fix culvert header where it is washing, and slope the road away from the outlet of the culvert (Figure 6).
- Continue to monitor and clean out the rubber water diversion devices that are in various locations on the trails.
- Continue to monitor and treat the invasive species. It will take many seasons to eradicate the phragmites australis, and should be treated each year during the growing season.

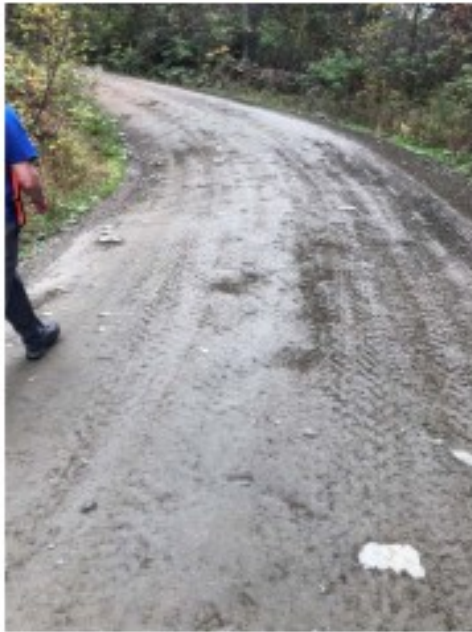
*Figure 5- Shows condition of trail*

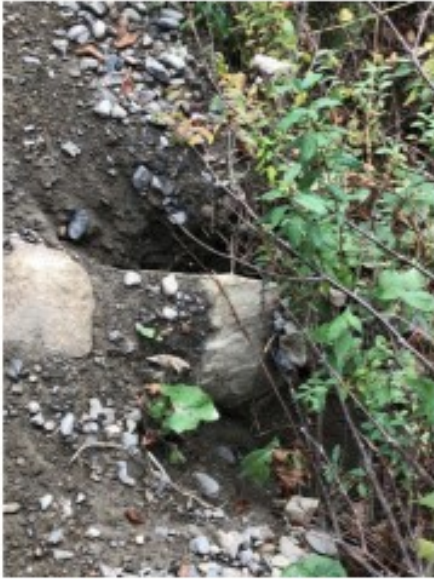
was one location where some sediment was running down the trail and getting into the brook next to the rock/culvert (Figure 6). There was discussion about re-grading the road on that section to grade it away from the stream and culvert.

*Figure 6- Depicting the area where the water is eroding around the culvert.*

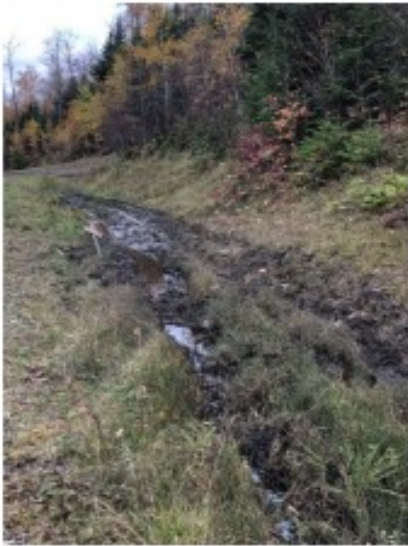
*Figure 7 -Shows some off trail riding*

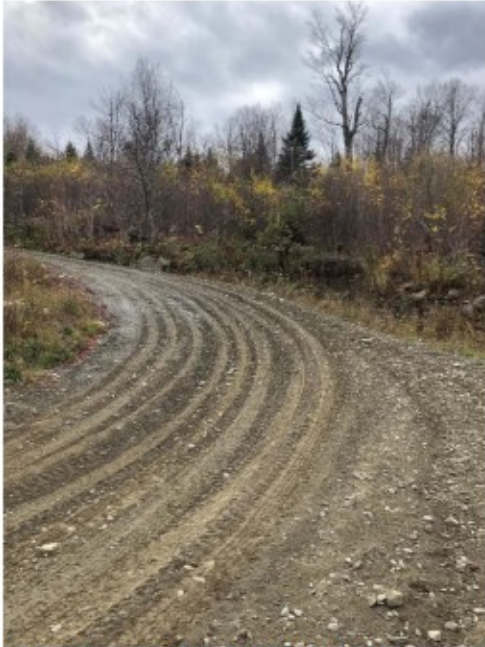
Each year, the sharp corner leading up to Kelsey Notch gets a significant berm. This happens from the dirt and rocks getting kicked out as the OHRVs turn and head up the hill, exacerbated with speed.

*Figure 8- Shows berm on corner of trail*

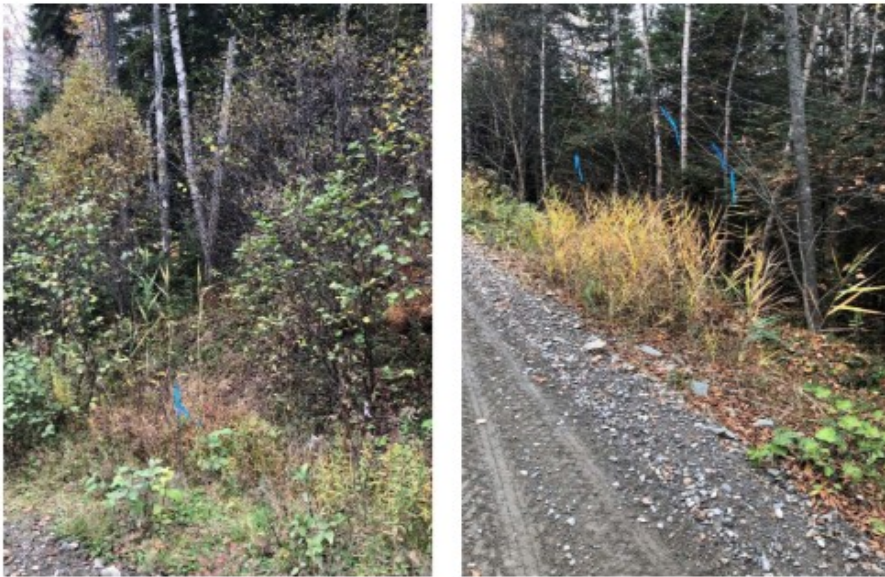
| In 2020, we found a few patches of *Phragmites australis*. These were located and flagged throughout the year to identify their locations and so they could be avoided by the Metallik ATV club performing maintenance.. These areas were treated on September 3, 2021 with glyphosate by Fish and Game staff who are licensed pesticide applicators.

Figure 9- Shows invasive species, phragmites
